## Pre-Application Consultation Pack

18 Dwellings  
Blast Road  
Brymbo  
Wrexham

BS 5837:20 12  
PRE-DEVELOPMENT TREE CONDITION SURVEY

*REFERENCE:*  
**TS59**

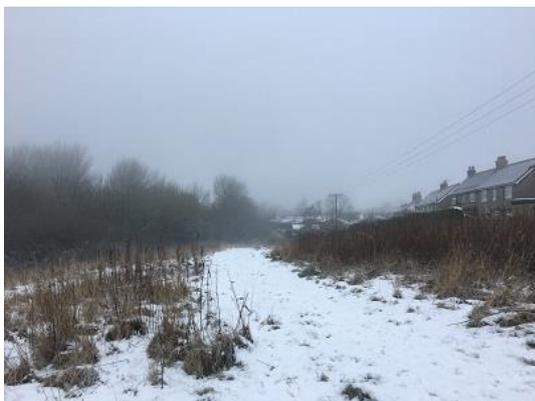
- 1.7.7 Immediately to the south of the site, on third party land which slopes away steeply to the south, there are 4 No. tree groups, G1, G2, G4 and G6. All appear to be unmanaged and are overcrowded, and all have been assessed as being Category C tree groups. G1 includes Oak, Ash, Birch, Hawthorn and Hazel. G2 and G4 include Ash, Blackthorn, Sycamore and Hawthorn, and G6 includes Eder, Blackthorn, Oak, Ash, Sycamore saplings, and Hawthorn. Recommendations for all include thinning the group, undertaking formative prune work, removing failed limbs and failed trees, as well as removing trees which have failed across the boundary fence.

View towards the western extent of the site, including G4, G6

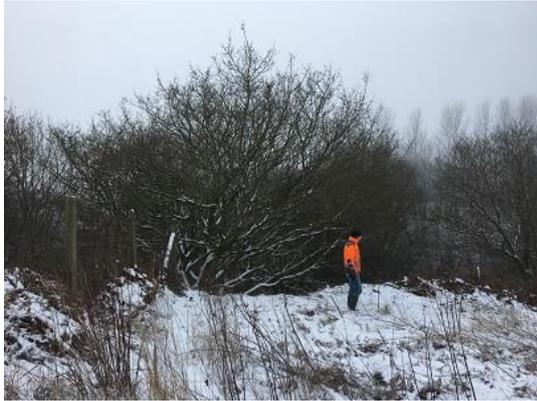
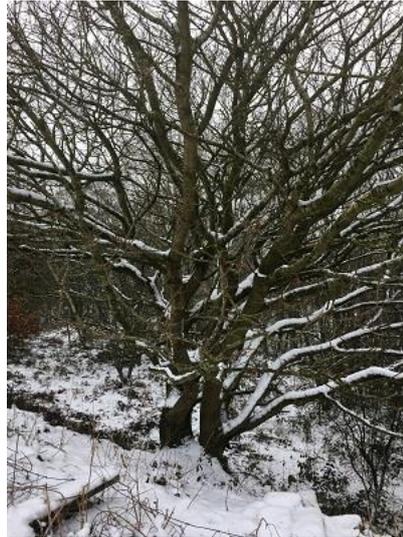
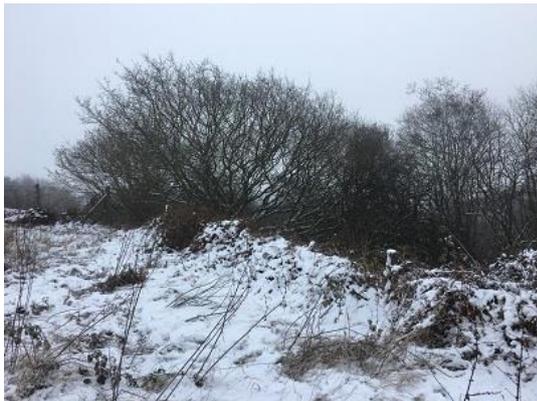
- 1.7.1 In total 4 No. individual trees, 9 No. tree groups and 2 No. hedgerows were recorded as part of the survey. Of these, 3 No. individual trees have been assessed as being Category C trees (T1, T2, T3), and 1 No. as a Category U tree (T4). All of the tree groups have been assessed as being Category C.
- 1.7.2 Recommendations relating to all of the trees surveyed are included in the Tree Survey Schedule, included in Appendix 1 of this report. Please note that tree groups G1, G2, G4, part of G6, G9 and G8 are understood to be under third party ownership, as such prior consent would need to be gained before undertaking any works to these trees.
- 1.7.3 Tree T1 is a Category C, semi mature Oak tree which is under third party ownership, located to the south of the site boundary. Its structural condition is mixed, with a

good crown, fair stem and poor basal area. Overall its physiological condition has been assessed as being fair.

View of T1, G1, looking south

View of T1, looking south

View of T1, G1, looking south east

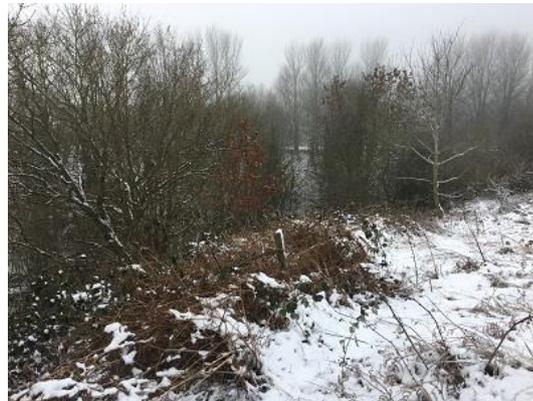
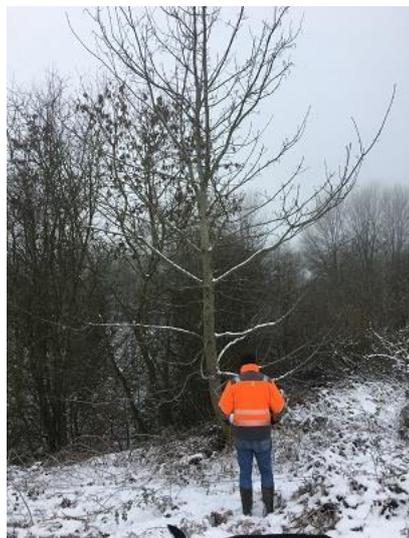
- 1.7.4 Further west, T2, a semi mature Sycamore tree is located close to the sites southern boundary. Overall it is considered to be of fair structural and physiological condition, and a Category C tree. It has a mis-formed stem, which may be due to previous light suppression.

View of T2, G1, looking south

View of T2, G1, looking south west

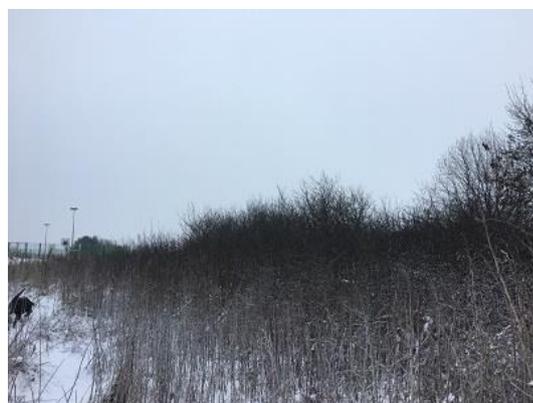
- 1.7.9 Within the site itself there are 2 No. stands of dense Blackthorn (group G3 and G5). These are located to the north of the sites southern boundary fence, and have both been assessed as being Category C groups of low value.

View of G2, G3, looking south east

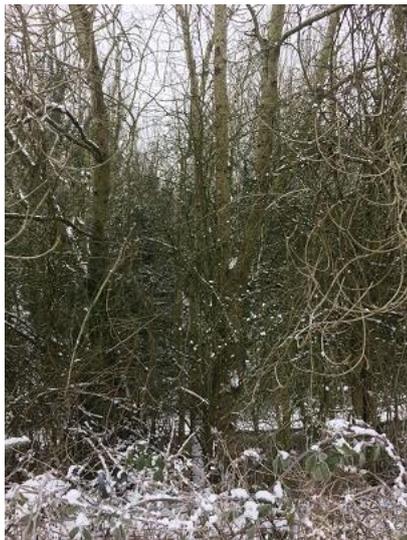
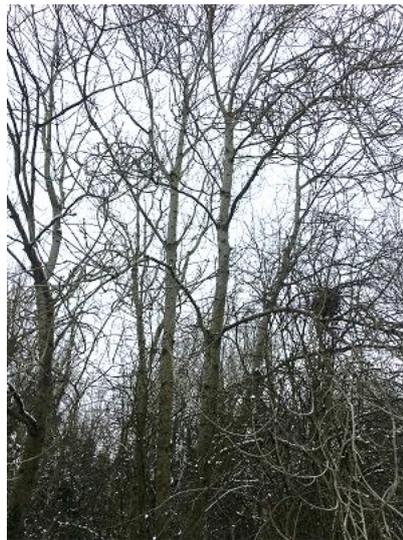
- 1.7.5 T3 is a semi mature Ash tree which is located towards the west of the site, and is located on third party land, at the top of a steep, south facing slope. This tree is leaning and has a once sided canopy, likely to be due to competition with the surrounding trees which are in close proximity. This tree has been assessed as being a Category C tree.

View of T3, looking south

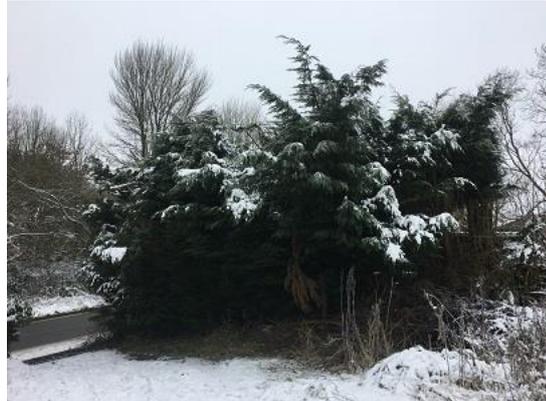
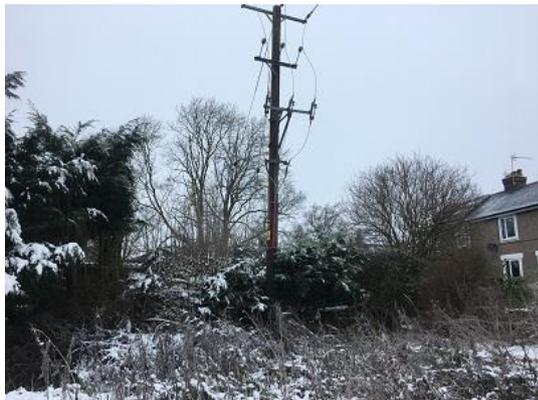
- 1.7.11 Hedgerow H1 is situated to the south west of G7, and runs along the sites western boundary. The southern extent of H1 is made up of overgrown and unkept Leylandii. The northern extent consists of Elder. This is lower in height and has been reduced as part of powerline clearance works here. It is recommended that the Leylandii section of hedgerow is removed and replaced with a more appropriate hedgerow species.

View of H1, looking south west

View of H1, looking north west

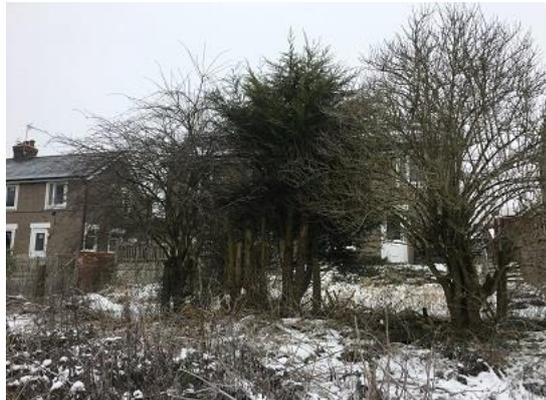
- 1.7.6 T4 is a mature Elder which is located at the north west of the site, to the south of the sites northern boundary fence. The form of this tree suggests that it may have been part of a stretch of hedgerow along this boundary, or may be self set. It has a poor assessed stem and basal area, and as such has been assessed as a Category U tree, and is recommended for removal.

- 1.7.10 At the western extent of the sites northern boundary, immediately adjacent to T4, is tree group G7, comprising Leylandii and Hawthorn. These trees are located to the north of the sites northern boundary, on third party land. Due to reduced condition and limited future potential these trees have been assessed as being Category C trees.

View of G7, T4, looking north

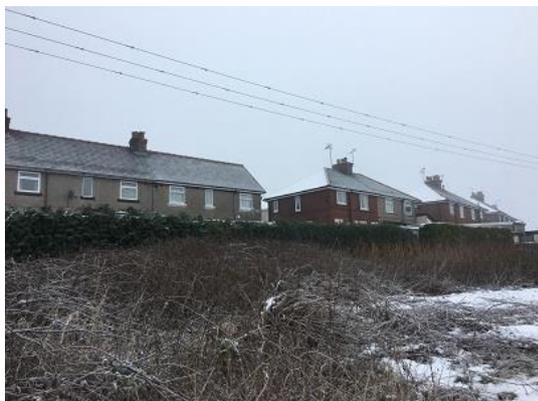
- 1.7.12 There is a stretch of well managed hedgerow (H2) to the south of 3 No. gardens to properties present along Argoed, which is located at the sites northern boundary. As this is located to the south of the boundary fence, it is understood that it is located within the site boundary. Species present include Leylandii and Privet.

View of H2, looking north east

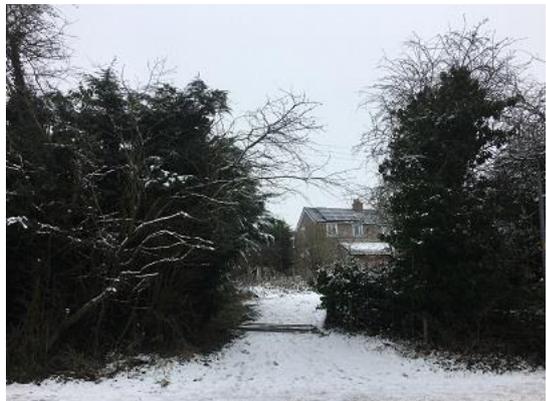
- 1.7.13 Tree group G9 is located to the west of the existing field access into the site (off Blast Road). These don't appear to be regularly maintained and are of reduced quality. Overall they are considered to be Category C trees.

View of G9, G6 (entrance to site off Blast Road), looking north

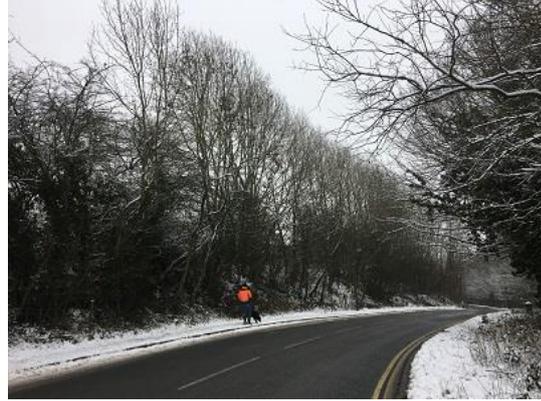
- 1.7.8 Further south of these tree groups, at the lower, southern extent of the slope, is tree group G8, which runs in parallel with, and to the north of Blast Road. These trees have been included in the survey for context. Species present include Ash, Hawthorn, Blackthorn, Holly, Oak, and Sycamore. Overall this group is considered to be Category C.

View of G8, (adjacent to Blast Road), looking south east
