**PROPOSED RESIDENTIAL DEVELOPMENT  
PHASE 2,  
GLYN FARM  
HEOL DIRION,  
COLWYN BAY**

**GEO-ENVIRONMENTAL INVESTIGATION REPORT**

**06063/GEIR**

**ROBERT E FRY & ASSOCIATES LTD.**  
45, Bridgeman Terrace  
Wigan, WN1 1TT

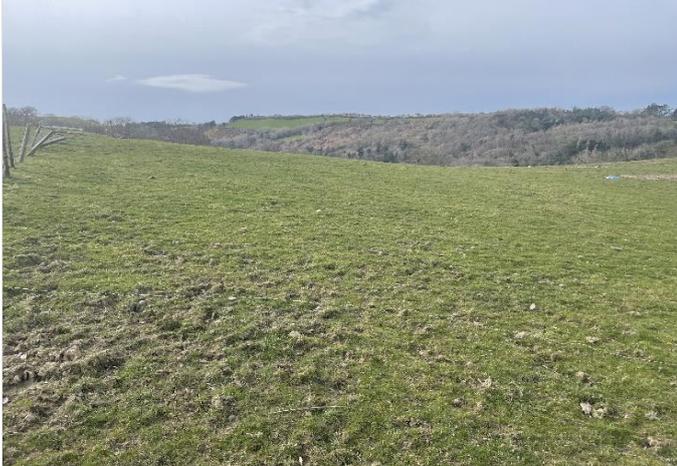
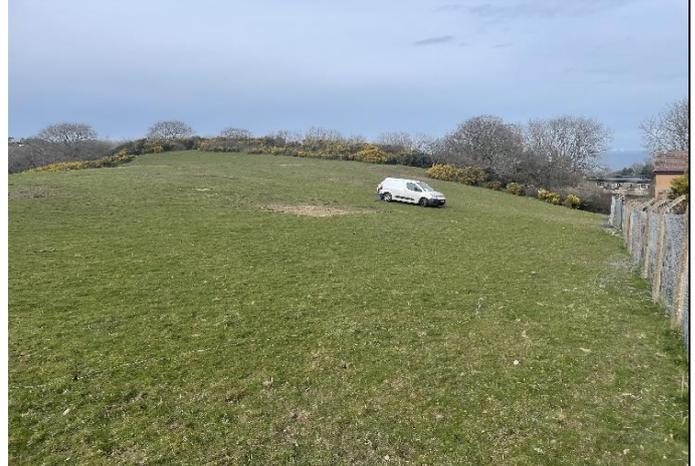
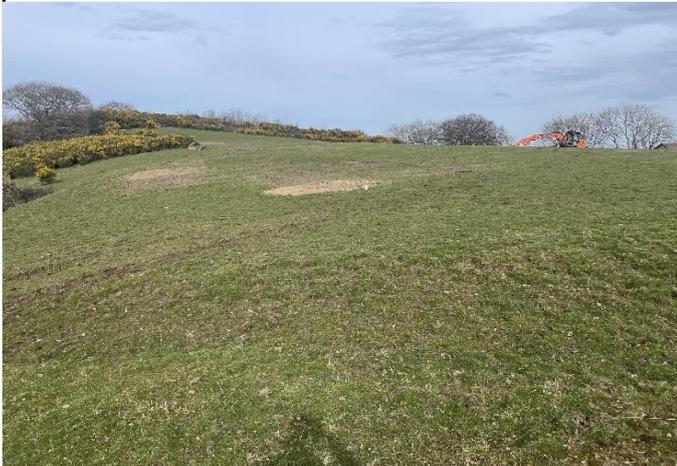
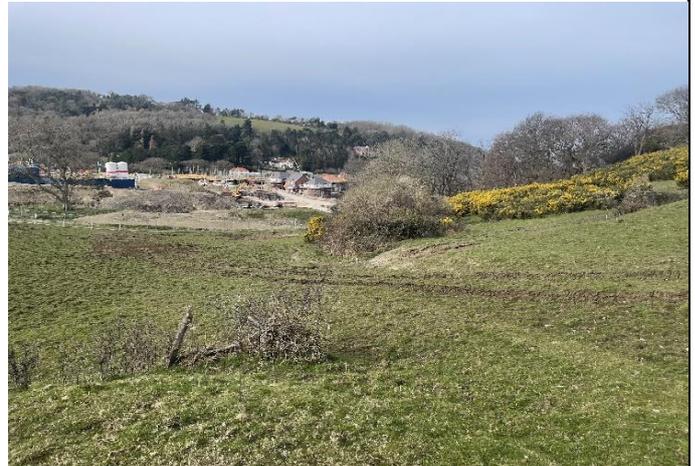
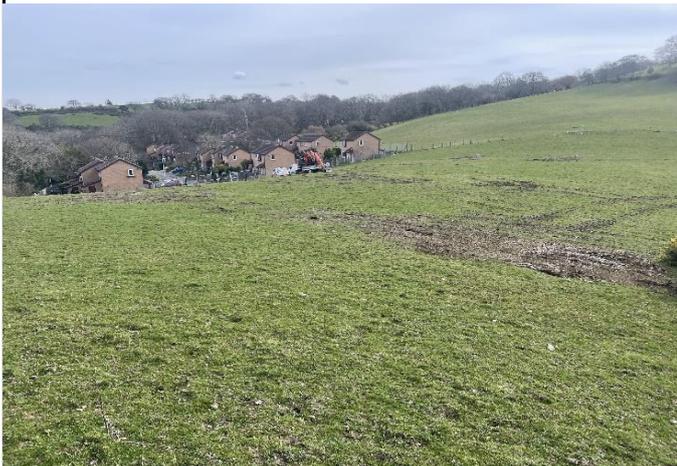
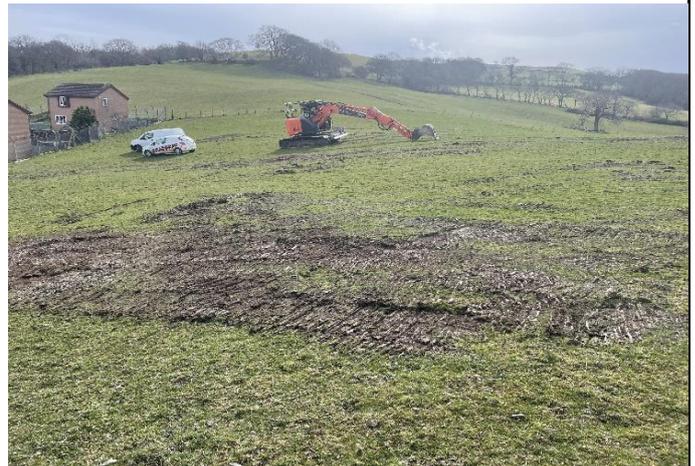
## WALKOVER SURVEY PHOTOGRAPHS

2.5.1 At the time of the investigation the site was in a vacant condition with a surface of short grass. Reference to Walkover Survey, drawing 06063/32, suggests that the site has been used for pastoral grazing for livestock.

2.7.2 The site walkover was conducted on the 15<sup>th</sup> March 2022 and at the time of the walkover the weather conditions were dry. The survey has confirmed that the site surface comprises of grass with a firm underlying topsoil layer.

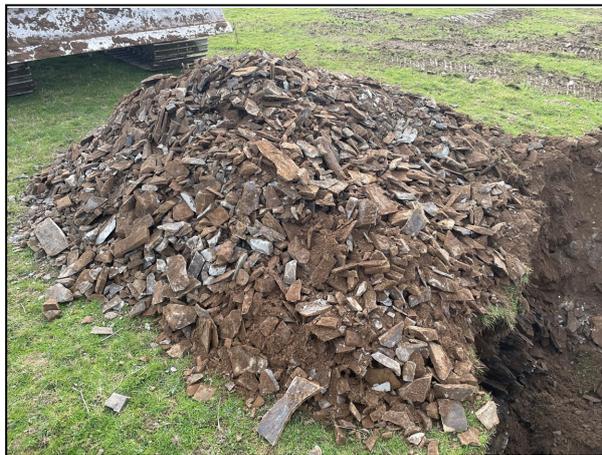
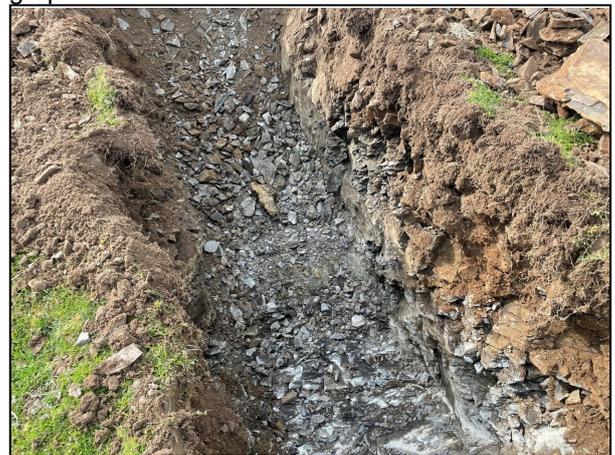
TP401 Arisings

Water Strike	Samples & In Situ Testing			Depth (m)	Level (m)	Legend	Stratum Description
	Depth	Type	Results				
	0.20	ES		0.40			Friable greyish brown, slightly gravelly, slightly sandy silty CLAY with many rootlets (Topsoil)
				1.20			Dark grey, gravelly moderately weak to medium strong cobble size fragments (Highly weathered MUDSTONE bedrock)
				1.30			Medium strong, thinly laminated dark grey, slightly weathered MUDSTONE End of Pit at 1.30m

Remarks: Unable to advance the hole further than 1.30m. No groundwater encountered. On completion trial pit was backfilled with arising.

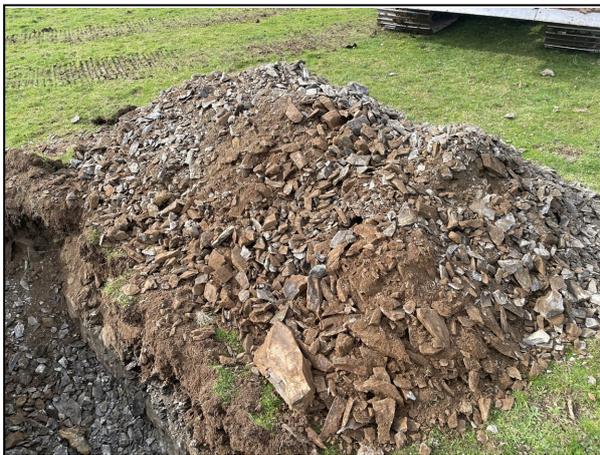
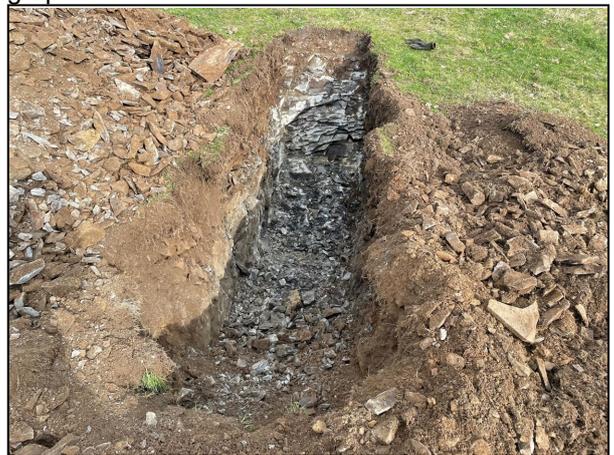
TP402 Arisings

Water Strike	Samples & In Situ Testing			Depth (m)	Level (m)	Legend	Stratum Description
	Depth	Type	Results				
	0.10	ES		0.20			Friable dark brown, slightly gravelly slightly sandy silty CLAY with many rootlets (Topsoil)
				0.80			Light grey and dark grey, slightly sandy fine to coarse moderately weak mudstone gravel size fragments with medium mudstone cobble size fragments (Highly weathered MUDSTONE bedrock)
				1.10			Medium Strong, thinly laminated dark grey moderately weathered MUDSTONE
							End of Pit at 1.10m

Remarks: Unable to advance the hole further than 1.10m. No groundwater encountered. On completion trial pit was backfilled with arisings.

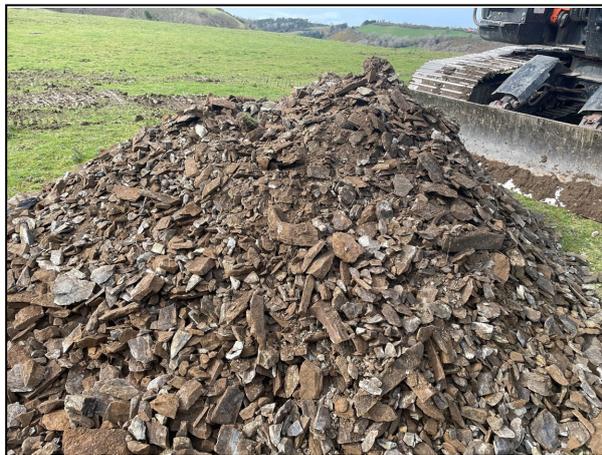
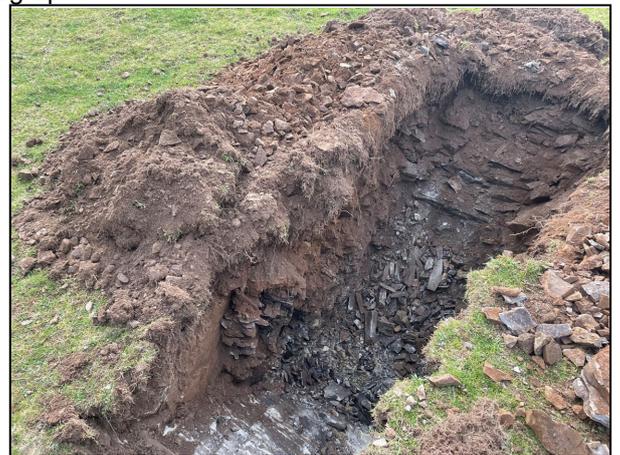
TP403 Arisings

Water Strike	Samples & In Situ Testing			Depth (m)	Level (m)	Legend	Stratum Description
	Depth	Type	Results				
	0.15	ES		0.20			Friable dark brown, slightly gravelly slightly sandy silty CLAY with some rootlets (Topsoil)
				1.50			Light grey and dark grey, gravelly moderately weak mudstone cobble size fragments (Highly weathered MUDSTONE bedrock).
				1.55			Medium Strong, thinly laminated dark grey moderately weathered MUDSTONE
							End of Pit at 1.55m

Remarks: Unable to advance the hole further than 1.55m. No groundwater encountered. On completion trial pit was backfilled with arisings.

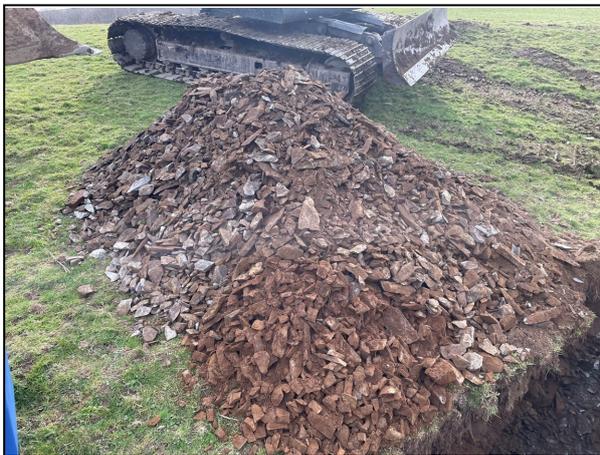
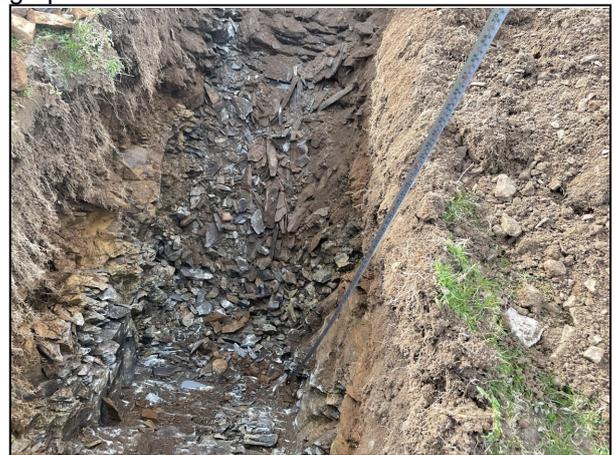
TP204 Arisings

Water Strike	Samples & In Situ Testing			Depth (m)	Level (m)	Legend	Stratum Description
	Depth	Type	Results				
	0.25	ES		0.35			Friable greyish brown, slightly gravelly, silty CLAY with some rootlets (Topsoil)
	0.40 - 0.60	D		0.60			Friable reddish brown slightly gravelly silty CLAY. Gravel is subangular to subrounded, fine to medium siltstone and mudstone.
	1.00	D		1.40			Dark grey, slightly sandy, fine to coarse moderately weak gravel size fragments. (Highly weathered MUDSTONE bedrock)
				1.50			Medium Strong, thinly laminated, dark grey, moderately weathered MUDSTONE
							End of Pit at 1.50m

Remarks: Unable to advance the hole further than 1.50m. No groundwater encountered. On completion trial pit was backfilled with arisings.

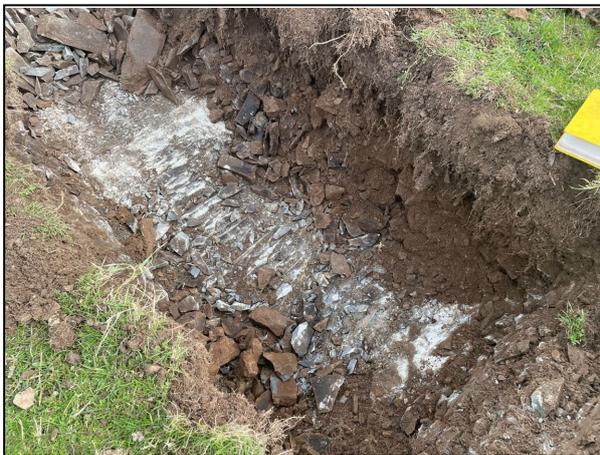
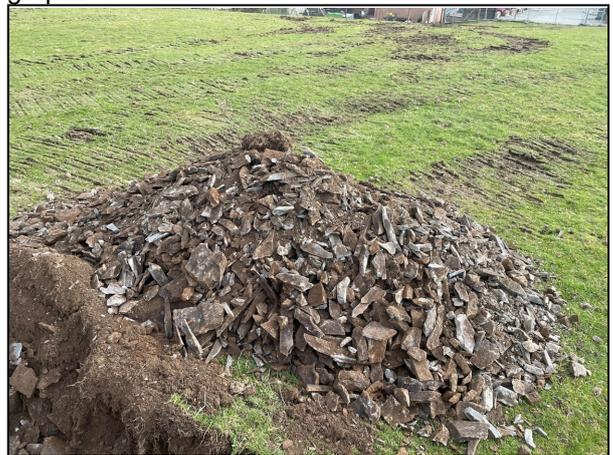
TP205 Excavation

Water Strike	Samples & In Situ Testing			Depth (m)	Level (m)	Legend	Stratum Description
	Depth	Type	Results				
	0.20	ES		0.30			Friable brown, slightly gravelly, slightly sandy silty CLAY with many rootlets (Topsoil)
				0.55			Dark grey, gravelly moderately weak mudstone cobble size fragments. (Highly weathered MUDSTONE bedrock)
				0.60			Medium strong, thinly laminated dark grey, slightly weathered MUDSTONE End of Pit at 0.60m

Remarks: Unable to advance the hole further than 0.60m. No groundwater encountered. On completion trial pit was backfilled with arisings.

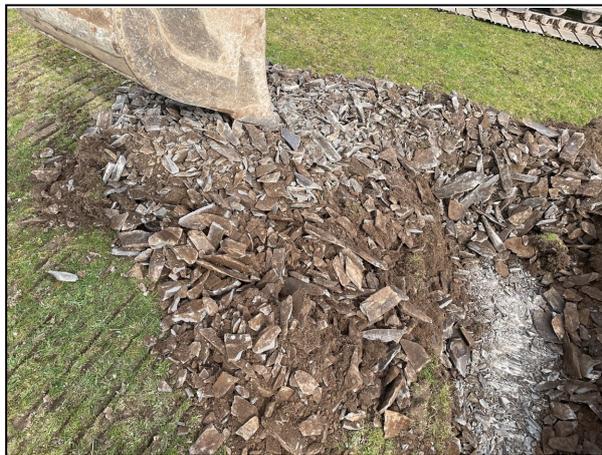
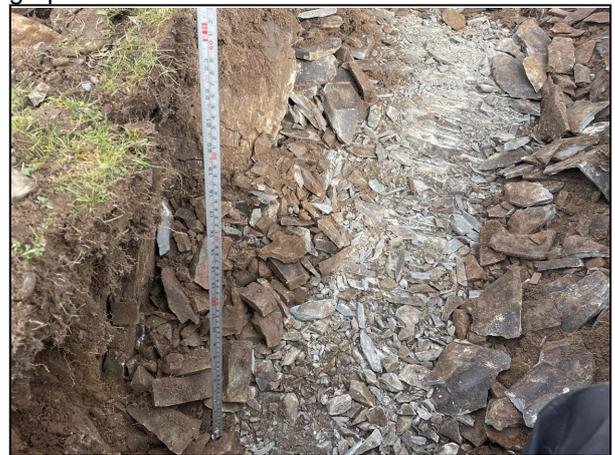
TP206 Arisings

Remarks: Unable to advance the hole further than 0.50m. No groundwater encountered. On completion trial pit was backfilled with arisings.

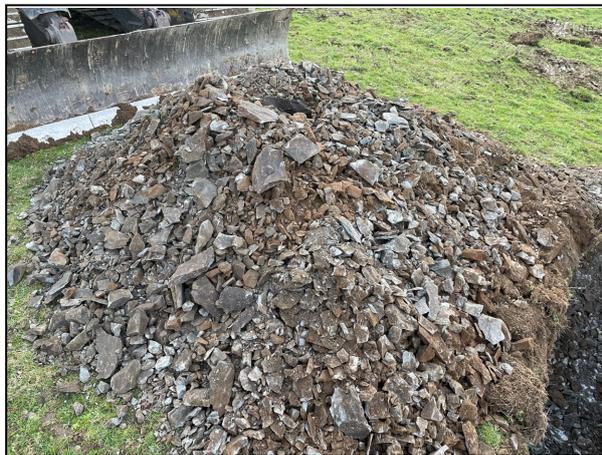
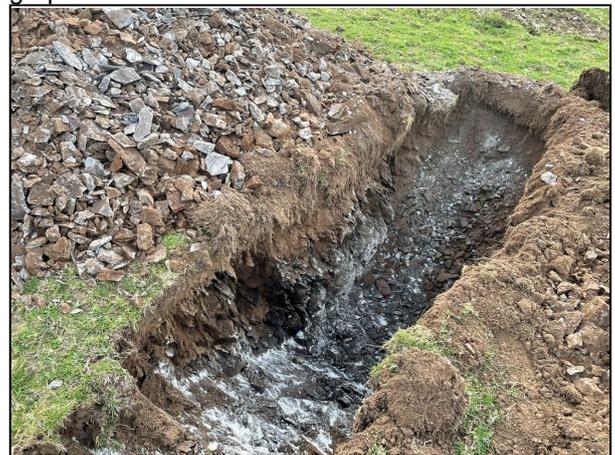
TP207 Arisings

Water Strike	Samples & In Situ Testing			Depth (m)	Level (m)	Legend	Stratum Description
	Depth	Type	Results				
	0.10	ES		0.20			Friable greyish brown slightly gravelly silty CLAY with some rootlets (Topsoil)
				1.00			Dark grey and light grey, sandy fine to coarse very weak to moderately weak mudstone gravel size fragments. (Highly weathered MUDSTONE bedrock)
				1.10			Medium strong thinly laminated, dark grey moderately weathered MUDSTONE
							End of Pit at 1.10m

Remarks: Unable to advance the hole further than 1.10m. No groundwater encountered. On completion trial pit was backfilled with arisings.

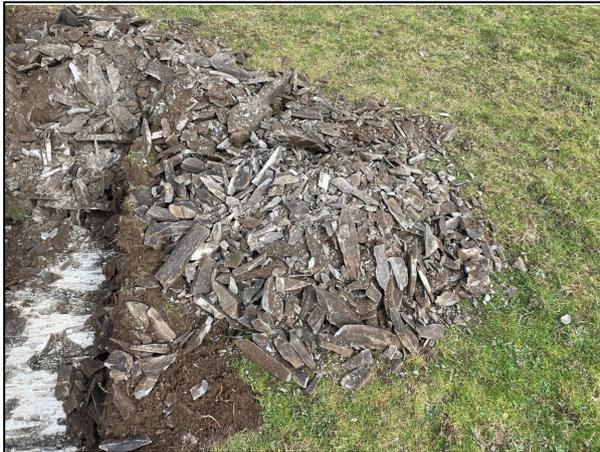
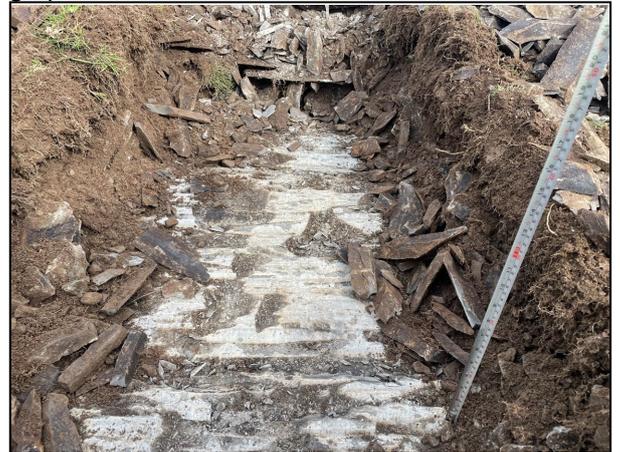
TP408 Arisings

Water Strike	Samples & In Situ Testing			Depth (m)	Level (m)	Legend	Stratum Description
	Depth	Type	Results				
	0.15	ES		0.30 0.35			Greyish brown, slightly gravelly, slightly sandy, silty CLAY with many rootlets and medium cobble size fragments of mudstone. (Topsoil)
	0.35	D					Medium strong, thinly laminated, slightly weathered MUDSTONE
							End of Pit at 0.35m

Remarks: Unable to advance the hole further than 0.35m. No groundwater encountered. On completion trial pit was backfilled with arisings.

Stability: Slight spalling from 0.00 to 0.35m

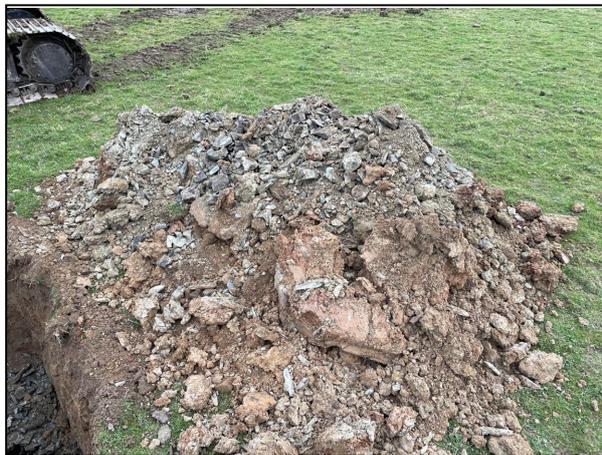
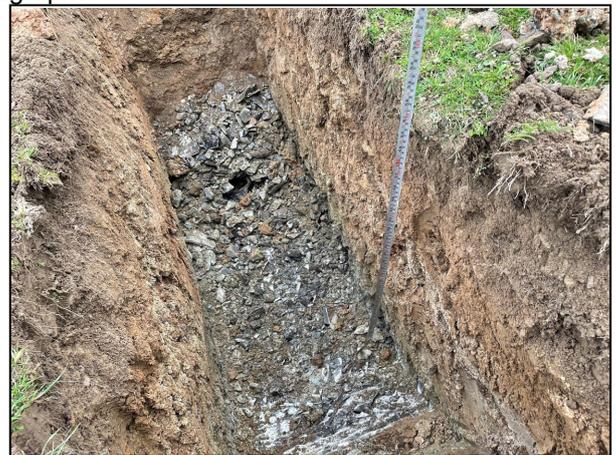
TP409 Arisings

Water Strike	Samples & In Situ Testing			Depth (m)	Level (m)	Legend	Stratum Description
	Depth	Type	Results				
	0.20	D		0.35		[Hatched pattern]	Friable greyish brown slightly gravelly silty CLAY with some rootlets (Topsoil)
	0.80	D		0.90		[Cross-hatched pattern]	Firm reddish brown and occasional light grey mottled, slightly gravelly slightly sandy silty CLAY. Gravel is subangular to subrounded fine to coarse siltstone and mudstone.
				1.10		[Dotted pattern]	Friable stiff, light grey, gravelly silty CLAY. Gravel size fragments are fine to coarse moderately weak mudstone (Completely weathered mudstone bedrock)
				1.20		[Horizontal lines]	Medium strong thinly laminated, dark grey moderately weathered MUDSTONE
							End of Pit at 1.20m

Remarks: Unable to advance the hole further than 1.20m. No groundwater encountered. On completion trial pit was backfilled with arisings.

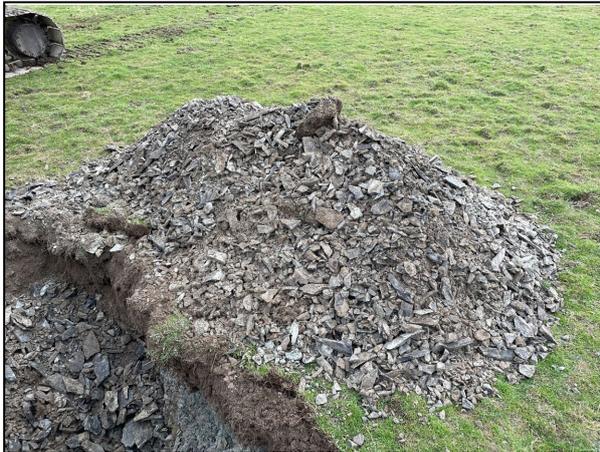
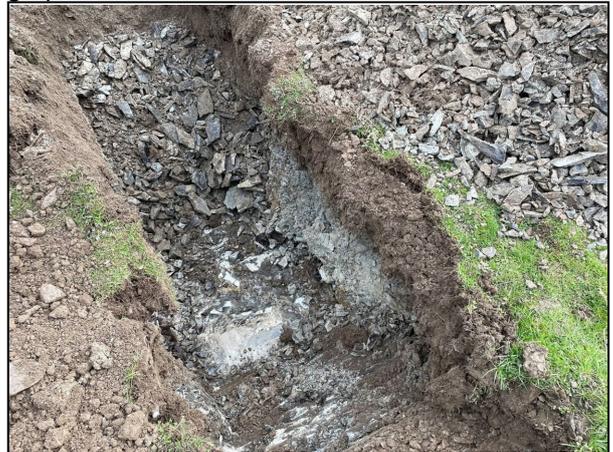
TP410 Arisings

Water Strike	Samples & In Situ Testing			Depth (m)	Level (m)	Legend	Stratum Description
	Depth	Type	Results				
	0.30	ES		0.35			Friable greyish brown slightly gravelly silty CLAY with some rootlets (Topsoil)
	0.75	D		0.85 0.90			Light grey and dark grey mottled, sandy slightly clayey moderately weak mudstone gravel size fragments (Highly weathered MUDSTONE bedrock)
							Medium strong thinly laminated, dark grey moderately weathered MUDSTONE End of Pit at 0.90m

Remarks: Unable to advance the hole further than 0.90m. No groundwater encountered. On completion trial pit was backfilled with arisings.

Stability: Slight spalling from 0.35 to 0.75m

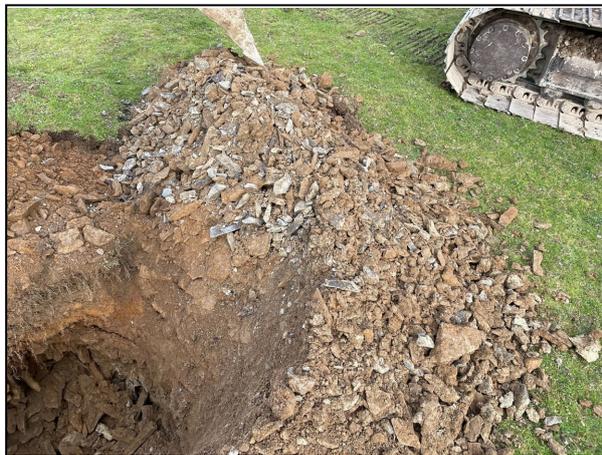
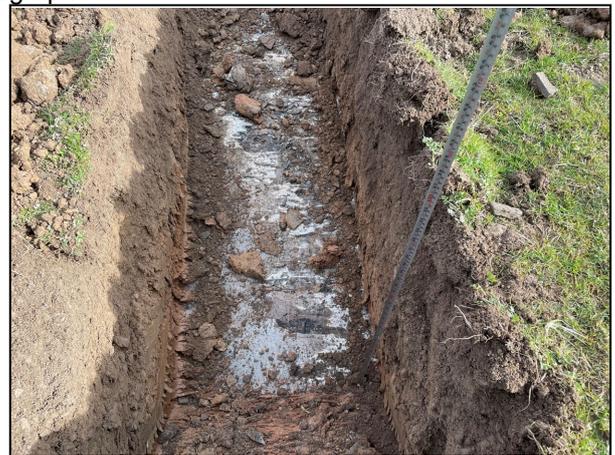
TP411 Arisings

Water Strike	Samples & In Situ Testing			Depth (m)	Level (m)	Legend	Stratum Description
	Depth	Type	Results				
	0.20	ES		0.40			Friable greyish and dark brown mottled, gravelly silty CLAY with some rootlets (Topsoil)
	0.60	D		0.80 0.85			Firm to stiff, brown and occasional orange and light grey mottled, slightly gravelly slightly sandy silty CLAY. Gravel is subangular to subrounded fine to medium, quartz and siltstone
							Medium strong thinly laminated, dark grey moderately weathered MUDSTONE End of Pit at 0.85m

Remarks: Unable to advance the hole further than 0.85m. No groundwater encountered. On completion trial pit was backfilled with arisings.

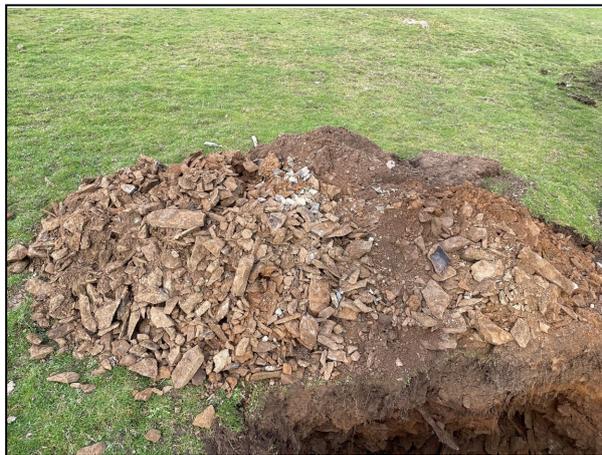
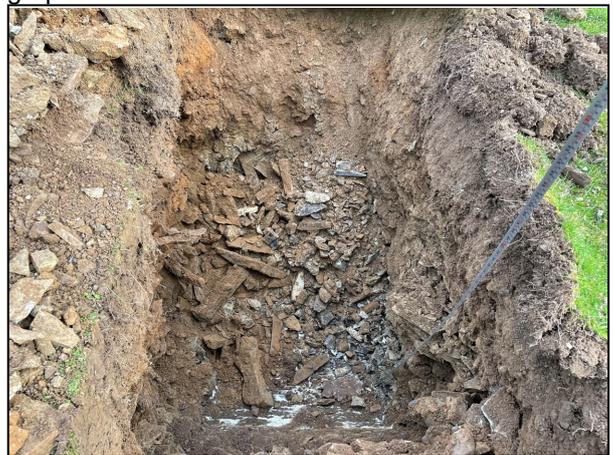
TP412 Arisings

Water Strike	Samples & In Situ Testing			Depth (m)	Level (m)	Legend	Stratum Description
	Depth	Type	Results				
	0.00 - 0.25	D		0.25			Friable stiff, dark brown, slightly gravelly, slightly sandy silty CLAY with many rootlets (Topsoil).
	0.75	D		1.10			Greyish brown, gravelly silty CLAY with high mudstone cobble size fragments. Gravel size fragments are fine to coarse moderately weak mudstone. (Completely weathered mudstone bedrock)
				1.30			Medium strong thinly laminated, dark grey highly weathered MUDSTONE
							End of Pit at 1.30m

Remarks: Unable to advance the hole further than 1.30m. No groundwater encountered. On completion trial pit was backfilled with arisings.

Stability: Spalling from 0.25 to 1.10m

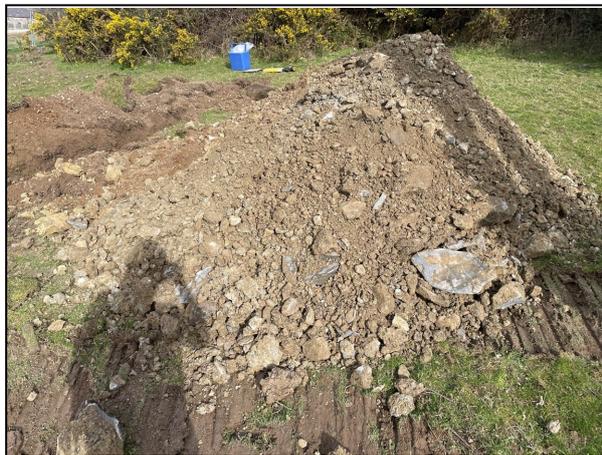
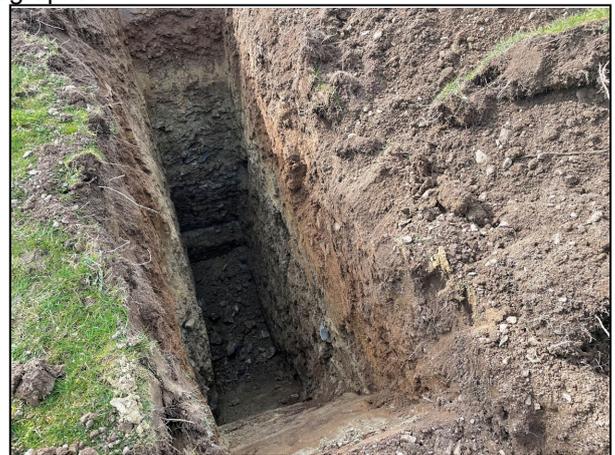
TP413 Arisings

Water Strike	Samples & In Situ Testing			Depth (m)	Level (m)	Legend	Stratum Description
	Depth	Type	Results				
				0.30			Friable dark grey, slightly gravelly slightly sandy silty CLAY with some rootlets (Topsoil)
				1.00			Friable brown, slightly gravelly, slightly sandy silty CLAY. Gravel is subangular to subrounded fine to medium mudstone.
				2.70 2.80			Friable stiff, light grey, slightly gravelly slightly sandy silty CLAY with low mudstone cobble size fragments. Gravel size fragments are fine to coarse very weak mudstone (Completely weathered mudstone bedrock)
							Medium strong, thinly laminated, dark grey moderately weathered MUDSTONE. End of Pit at 2.80m

Remarks: Unable to advance the hole further than 2.80m. No groundwater encountered. On completion trial pit was backfilled with arisings.

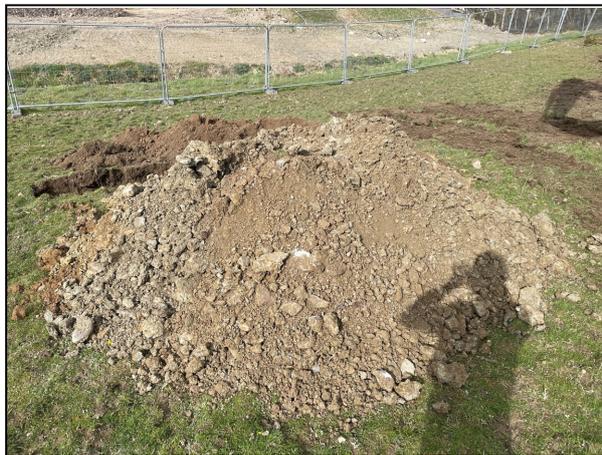
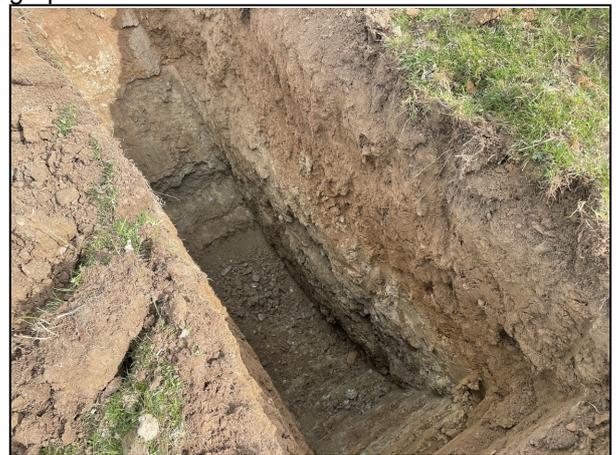
TP214 Arisings

Water Strike	Samples & In Situ Testing			Depth (m)	Level (m)	Legend	Stratum Description
	Depth	Type	Results				
				0.35			Friable, dark brown, slightly gravelly, slightly sandy silty CLAY with some rootlets (Topsoil)
				1.20			Friable brown, slightly gravelly, slightly sandy silty CLAY. Gravel is subangular to subrounded fine to medium siltstone
				2.65 2.70			Friable firm to stiff slightly gravelly slightly sandy silty CLAY with low mudstone cobble size fragments. Gravel size fragments are fine to coarse extremely weak mudstone (Completely Weathered Sandstone Bedrock)
							Medium Strong, thinly laminated light grey moderately weathered bedrock. End of Pit at 2.70m

Remarks: Unable to advance the hole further than 2.70m. No groundwater encountered. On completion trial pit was backfilled with arisings.

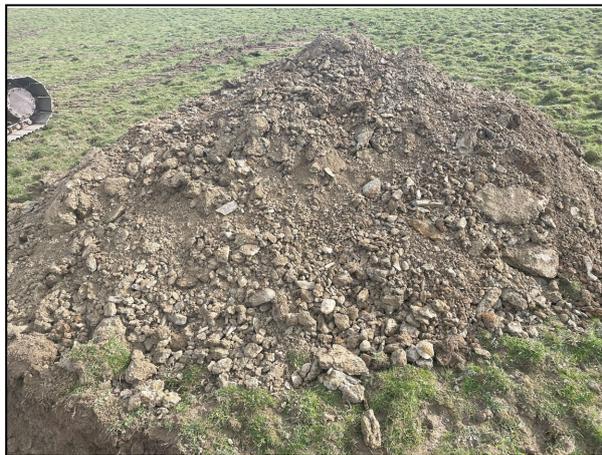
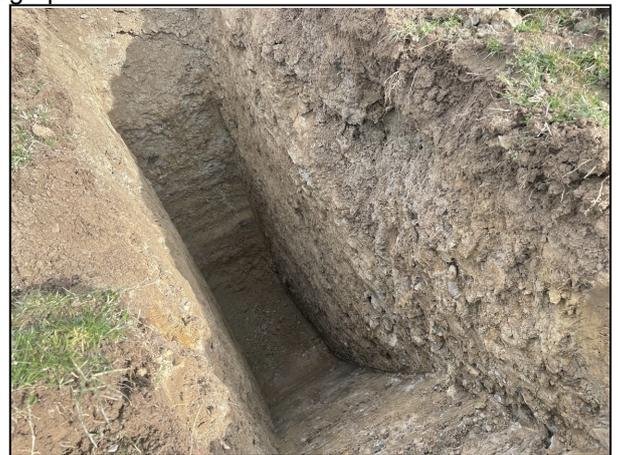
TP415 Arisings

Water Strike	Samples & In Situ Testing			Depth (m)	Level (m)	Legend	Stratum Description
	Depth	Type	Results				
				0.35			Friable dark brown, slightly gravelly slightly sandy silty CLAY with some rootlets (Topsoil)
							Friable brown, slightly gravelly slightly sandy silty CLAY with low mudstone cobble size fragments. Gravel size fragments are fine to coarse, very weak mudstone.. (Completely weathered bedrock)
				3.00			End of Pit at 3.00m

Remarks: Trial pit completed at 3.00m. No groundwater encountered. On completion trial pit was backfilled with arisings.

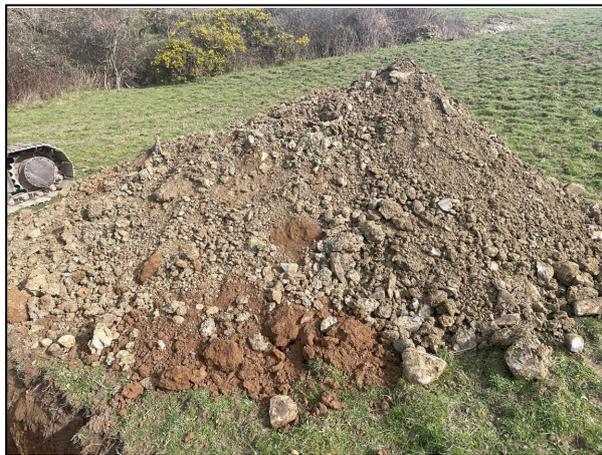
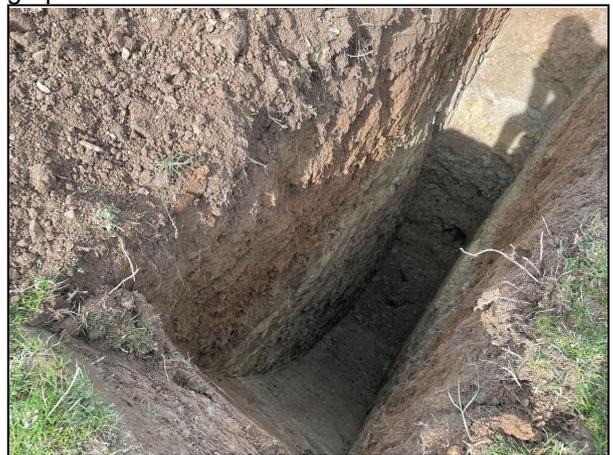
TP416 Arisings

Water Strike	Samples & In Situ Testing			Depth (m)	Level (m)	Legend	Stratum Description
	Depth	Type	Results				
				0.30			Greyish brown, slightly gravelly slightly sandy silty clay with some rootlets (Topsoil)
				1.10			Friable firm, slightly gravelly, slightly sandy silty CLAY. Gravel is subangular to subrounded fine to medium quartz and mudstone
				3.20			Friable stiff, light grey, slightly gravelly, slightly sandy silty CLAY with low mudstone cobble size fragments. Gravel size fragments are fine to coarse, very weak mudstone (Completely weathered mudstone bedrock).
							End of Pit at 3.20m

Remarks: No groundwater encountered. On completion trial pit was backfilled with arisings.
