# Phase I Preliminary Risk **Assessment (PRA)**

# **Guys Cliff Nursing Home, Colwyn Bay**

**Client: Wales and West Housing**

Reference: 32999-SUT-ZZ-00-RP-G-7101

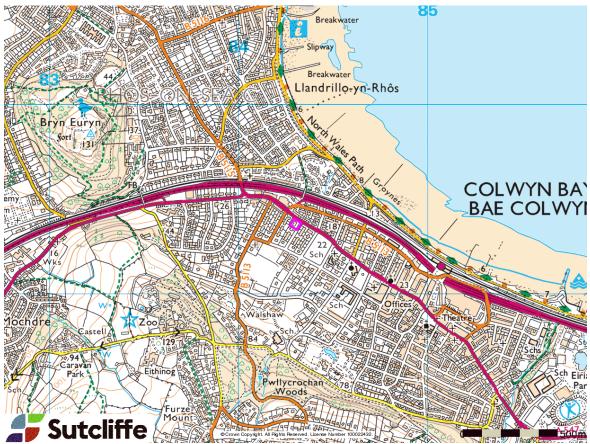
Figure 1: General Location of Site

The site address is located at 79-81 Conway Road, Colwyn Bay, LL29 7LN at National Grid Reference (NGR) 284300, 379370 and is approximately 0.92km north-west from the Bay of Colwyn Town Council.

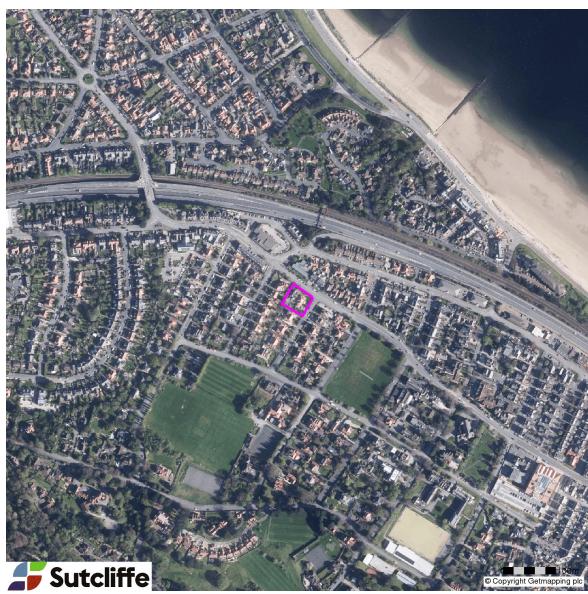
Figure 3: Aerial Photograph

The site is roughly square in shape, 0.2ha in area and can be accessed via Conway Road and Alexandra Road to the north-east and south-east of the site respectively. The site has an uneven topography and slightly raised compared to the roads noted previously. The site comprises a two-storey nursing home in the centre with hardstanding roughly located in the northern and southern sections of the site. Areas of soft landscaping are also noted eastern and western sections of the site. A low stone wall with shrubbery and trees is noted to mark

the north-eastern, south-eastern and south-western boundaries of the site. A wooden fence marks the north-western boundary.

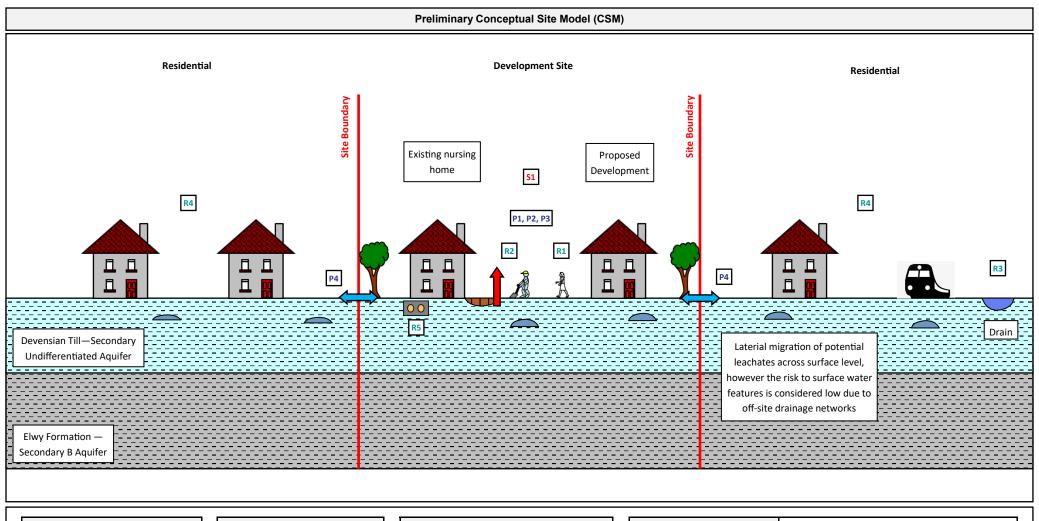
Figure 4 – Preliminary Conceptual Site Model

Receptor			
R1	Future Site Users		
R2	Construction Workers		
R3	Controlled Waters		
R4	Adjacent Site Users		
R5	Infrastructure & Buried Services

Ref.	Pathway	Description
P1	Direct contact with potential contaminants.	Dermal absorption, ingestion and inhalation of contaminants via direct
P2	Ingestion of potential contaminants.	contact.  Construction workers may come into contact during the site works, however this will be for a short time and therefore limited exposure will
Р3	Inhalation of potential contaminants.	occur. PPE can be used and worn as a precaution to reduce the risk.
P4	Leaching and migration of contaminants.	Downward migration of potential leachates is not envisioned to the underlying impermeable Secondary Undifferentiated and B Aquifers.  Migration off-site may be likely due to the presence of the impermeable Glacial Till potentially facilitating lateral migration of perched groundwater. On site drainage may be at risk from shallow contamination if present.
P5	Vertical and lateral migration of ground gases / vapours.	Hydrocarbon spills / leaks may be present but are unlikely to translate into a vapour risk due to anticipated low volumes.  No permanent gas sources are envisioned onsite; the thickness of Made Ground are not anticipated deep enough to pose a permanent gas risk.  No viable sources of offsite permanent gas sources or migration pathways to site envisioned.

1. Hazard Identification 2. Hazard Assessment			3. Risk Estimation		4. Risk Evaluation	E Astion required					
Contaminant Source		Pathway		Re	eceptor	Consequence	Probability	Classification	5. Action required			
		P1	Direct contact with potential contaminants.	R1/2	Site users	Medium	Low	Moderate / Low Risk				
	Potentially contaminated soil on-site	P2	Ingestion of potential contaminants.	R1/2	Site users	Medium	Low	Moderate / Low Risk				
C4		contaminated	•	•	P3	Inhalation of potential contaminants.	R1/2	Site users	Severe	Low	Moderate Risk	It is possible that harm could arise to a designated receptor from an identified hazard. Investigation is normally required to clarify the risk
			P4	Leaching and migration of contaminants.	R3/5	Surface Water Features	Medium	Low	Moderate / Low Risk	and to determine the potential liability. Some remedial works may be required in the longer term.		
		De	Vertical and lateral	R1	Site users	Severe	Unlikely	Moderate / Low Risk
