Territorial Army Centre, Prestatyn Ecological Assessments

Report Reference: EE.4839.24.LB

- 1.1.1 Enfys Ecology Limited was commissioned by Wales & West Housing to conduct a series of ecological assessments, including a Preliminary Ecological Appraisal (PEA), Preliminary Bat Roost Assessment (PRA), emergence surveys and an otter and water vole survey, at the site of the former TA Centre, Marine Road, Prestatyn, LL19 7HA.

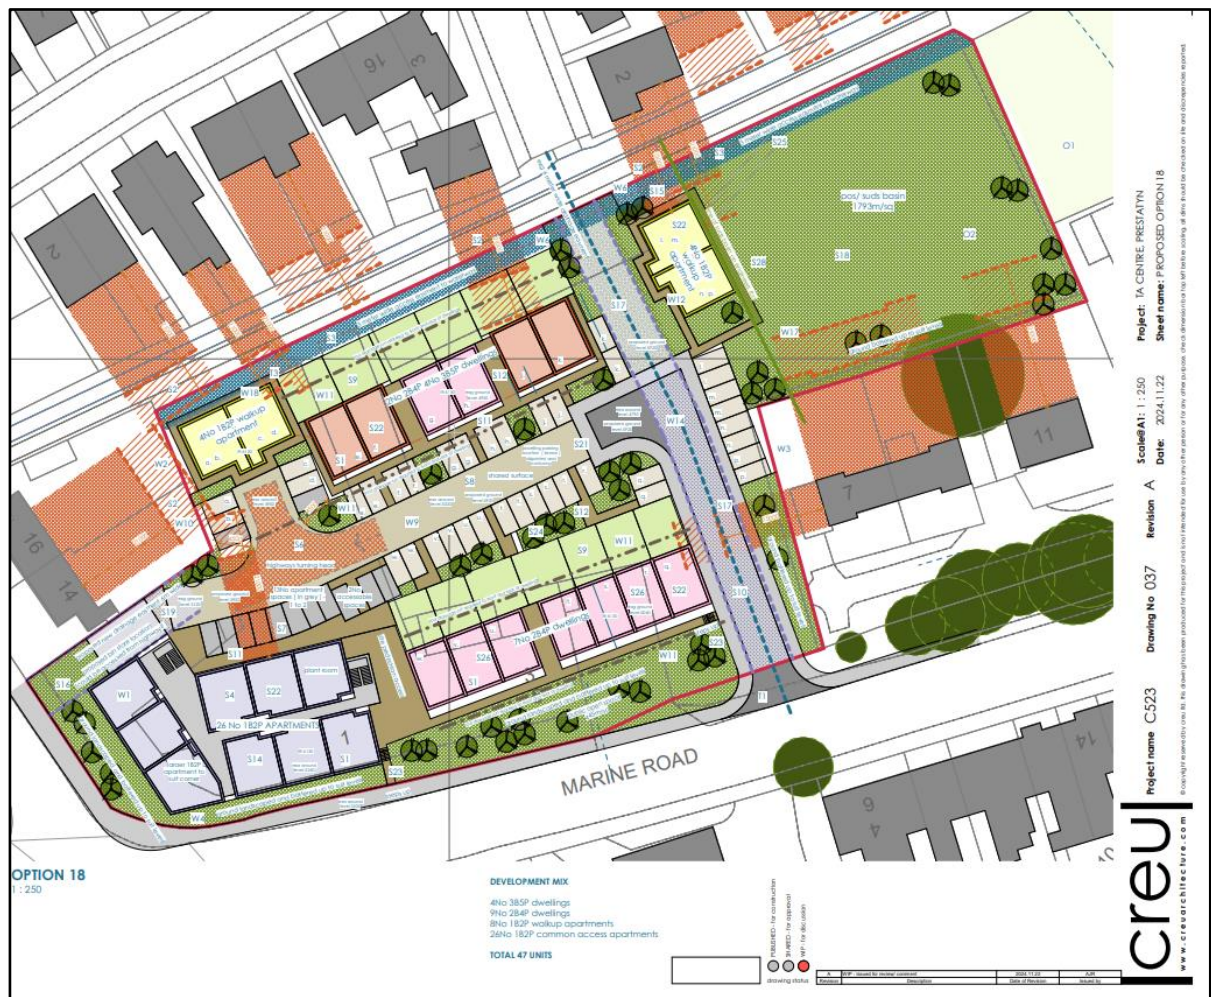
Figure 1.1 Proposed Site Plan ©Creu Architecture

- 1.1.2 The proposed development comprises the demolition of the existing TA Centre buildings, to be replaced with a residential housing development comprising 47 units, including dwellings, apartments, and public open space (Figure 1.1).

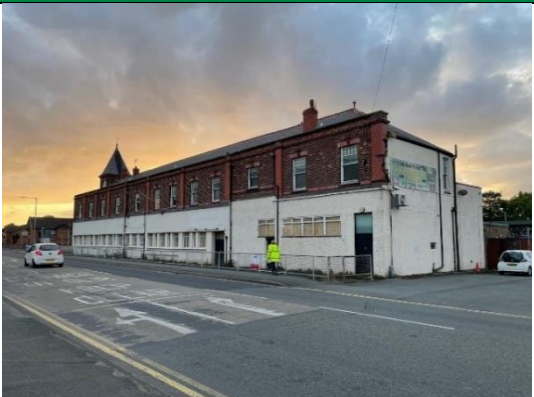
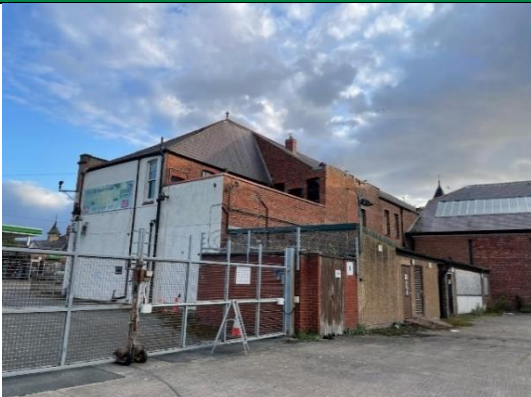
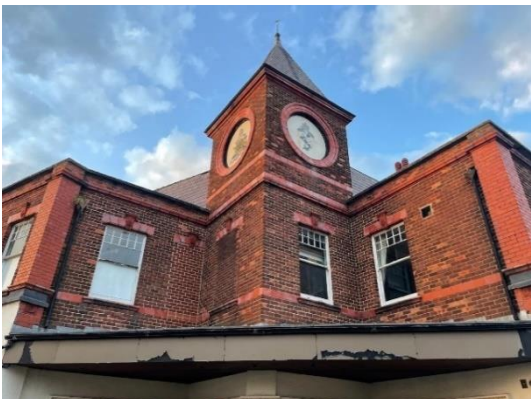
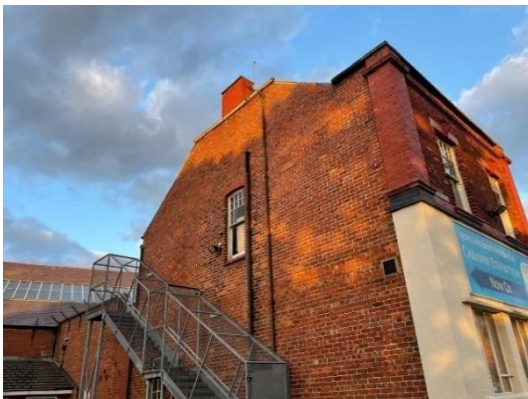
Description	Example Photos	
Building 1		
<ul style="list-style-type: none">• Large two-storey building, located at the south western corner of the site.• The main roof was pitched and slated including ridge tiles, with single and two-storey flat roofed sections on the northern elevation.• The external walls were built higher than the edge of the roof so no facias or soffits were present.

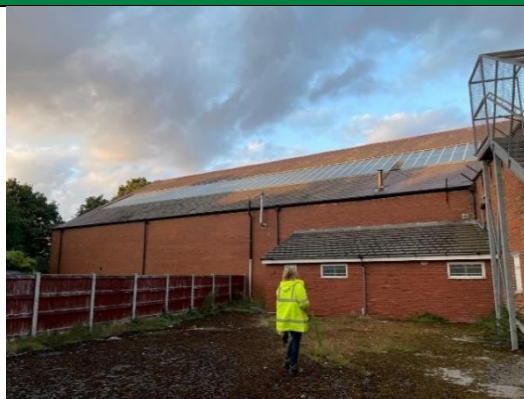
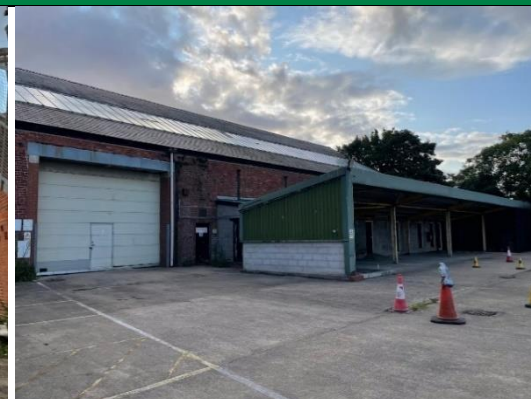
Building 2

- Large brick-built warehouse building located at the north western corner of the site.
- Pitched slated roof, with ridge tiles and skylights running the whole length of the roof on both pitches.
- No fascias or soffits at the eaves.

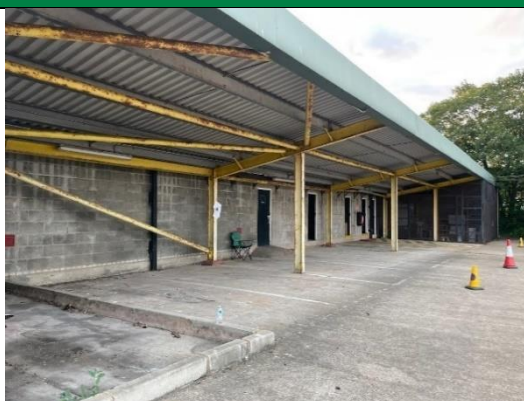
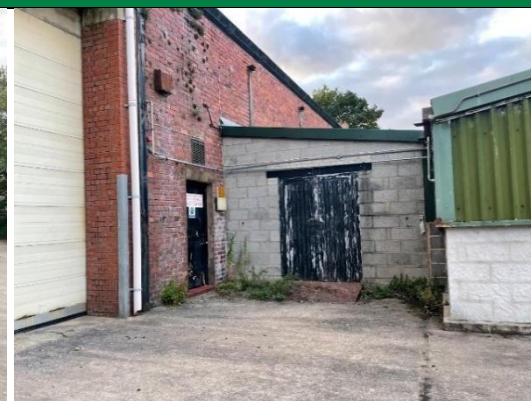
**Building 3 - External**

- Single storey, block-built building with a mono-pitched roof.
- Roof covering was corrugated metal sheeting.
- Large corrugated metal canopy on the eastern elevation.

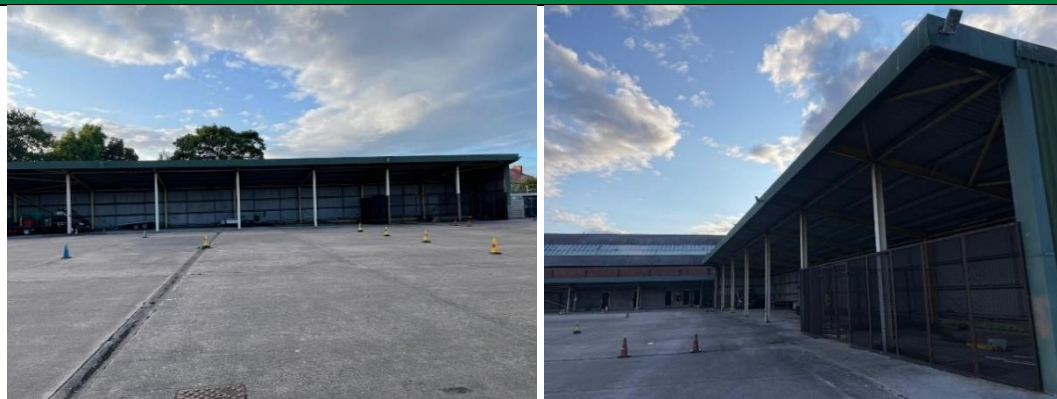
**Open Shed**

- Large shed of blockwork and corrugated metal construction on the northern boundary of the site.
- Fully open on the southern elevation.

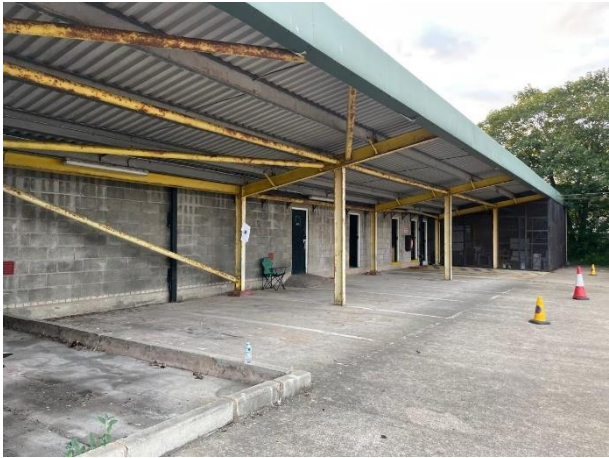
Description	Example Photos
<ul style="list-style-type: none"> At the time of the survey, the doors to the store rooms within Building 3 were open, allowing access for bats. The rooms themselves were well-sealed, with no gaps or crevices that would be suitable for a day roost. The frequency with which these doors are left open is currently unknown.

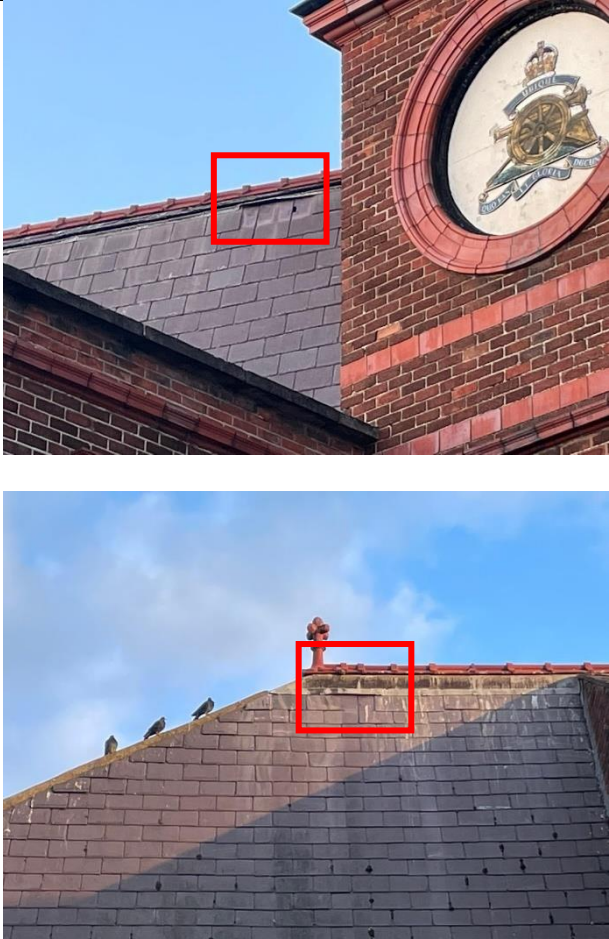
<ul style="list-style-type: none"> The roof and rooflines were generally in good condition; however, a small number of potential gaps and crevices where slates were missing or slipped were identified on Building 1.

10.3.2 The ecologist will carry out an inspection of the potential roosting areas prior to the start of any works using an endoscope and high-powered torch where necessary. If it can be determined that no bats are present then works can continue in these areas without supervision. If there are any areas that cannot be inspected fully, or bats are found, then works to these areas will be carried out under supervision.

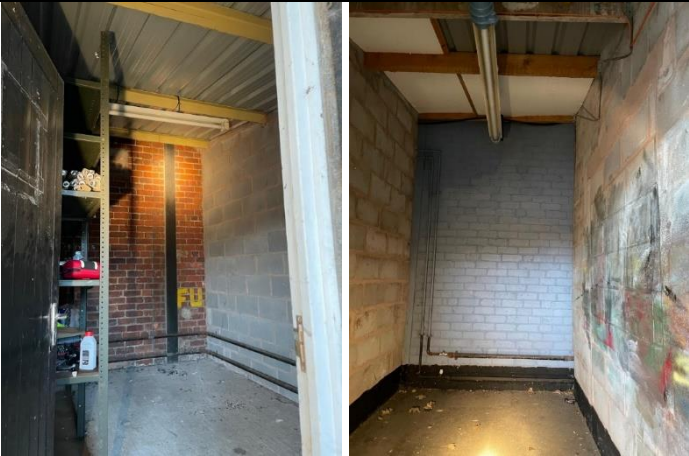
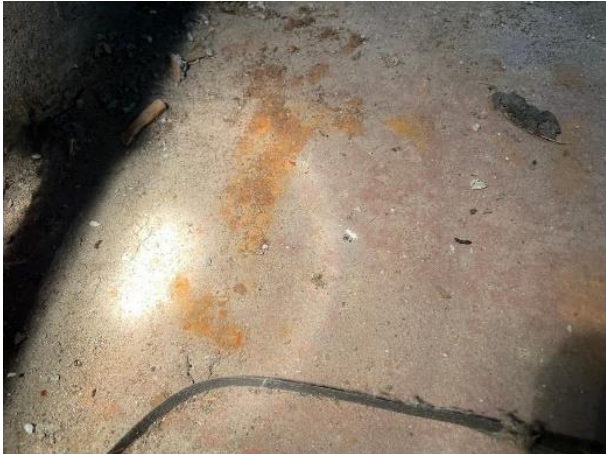
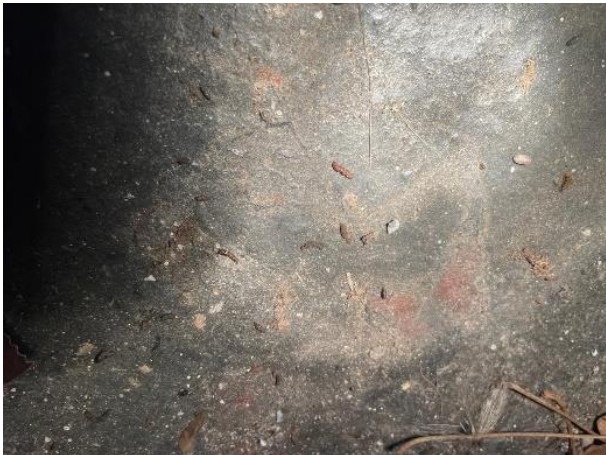
Evidence	Photos
<ul style="list-style-type: none">A small number (approximately ten), of scattered bat droppings were found in two of the store rooms of Building 3. Some looked to be old and degrading, while others looked to be more recent. A sample of the droppings were sent to SureScreen Scientifics for DNA analysis, which confirmed the sample to be Common Pipistrelle (DNA Analysis Report in Appendix B).The roofs within the two store rooms were exposed corrugated metal, which in one of the rooms was partially covered with wooden panels.The rooms were well sealed with no cracks or crevices within the blockwork.The space between the panelling and the corrugated metal roof is unlikely to provide a suitable roosting place.	<div>

10.1 **As Building 3 has a known bat roost, no works to this building must commence until a licence has been obtained from NRW. A licence can only be applied for following the granting of planning permission and the discharge of any ecology related conditions. Once submitted the licence application takes 40 working days to be processed (or more if any there are any queries).**

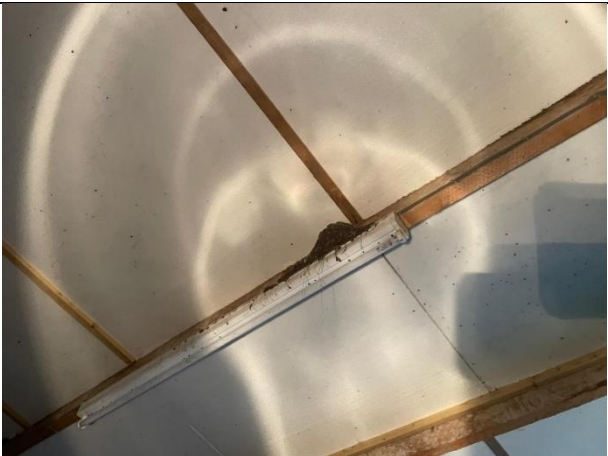
<ul style="list-style-type: none">• Nests consistent with house martins, were present above a light fitting and against one of the beams, within the store rooms of Building 3.

10.5.2 Where possible, work to these areas should be avoided during the bird nesting season (April to September inclusive). If this is not possible, a nesting bird check must be carried out no more than 48 hours before works commence. If birds are found nesting during any point in the works, all works to that area must **stop** and only continue once the chicks have fledged. The existing house martin nests will be retained, where possible, as the nests may be reused.

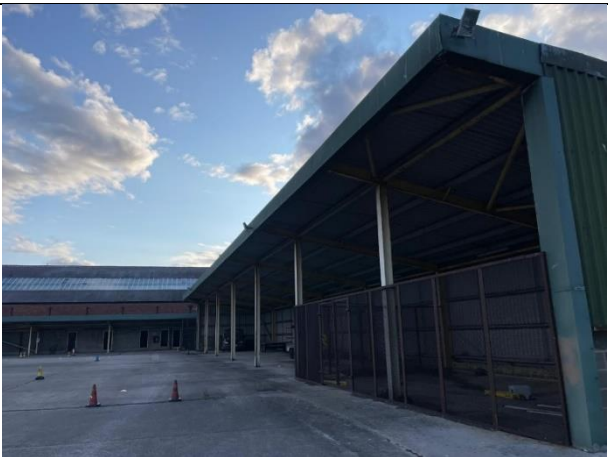
<ul style="list-style-type: none">• There were a number of pigeons roosting within the roof of the open shed. It is not known if active nests were present.

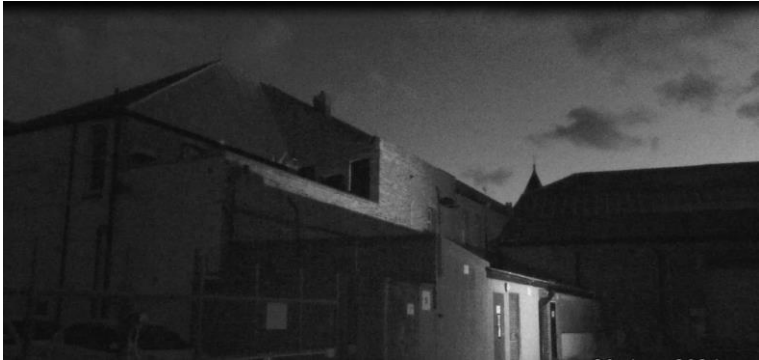
Emergences
<ul style="list-style-type: none">There were no emergences during the survey
General Activity
<ul style="list-style-type: none">The first bat to be detected was at 20:54, a common pipistrelle commuting from east to west, along the northern site boundary.A common pipistrelle was recorded passing briefly between the buildings at 20:57 and 20:59 and then three common pipistrelles were recorded foraging within the yard area between 21:07 and 21:23.A noctule was briefly heard but not seen at 21:06.No bats were recorded along the southern or western elevations of the building.
Screenshot from the darkest part of the survey

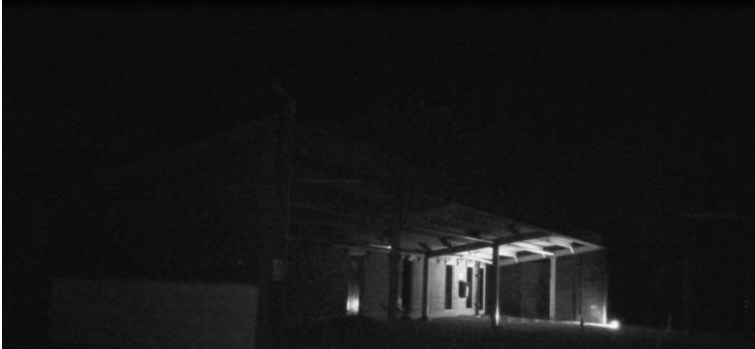
Emergences	
<ul style="list-style-type: none"> There were no emergences during the survey 	
General Activity	
<ul style="list-style-type: none"> The first bat to be detected was at 19:58, a common pipistrelle commuting along the northern site boundary and across the top of Building 3. A common pipistrelle was recorded foraging and commuting within the central yard area, between the buildings, at 20:18, 20:26, 20:29 and 20:45. Brief passes by a common pipistrelle was heard but not seen to the south of the site at 20:27 and again at 20:32. A common pipistrelle was recorded foraging along Bastion Rd, along the western site boundary at 20:16 and then again at 20:51. 	
Screenshot from the darkest part of the survey

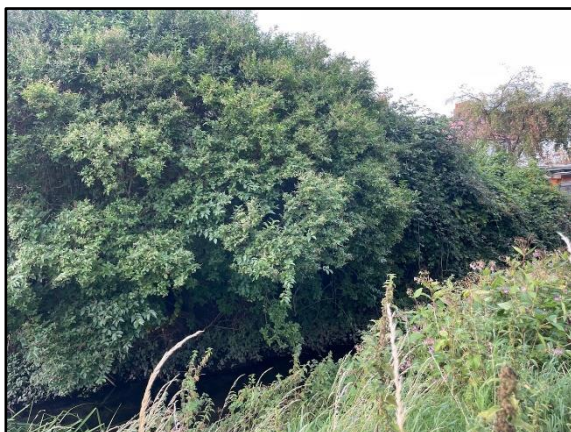
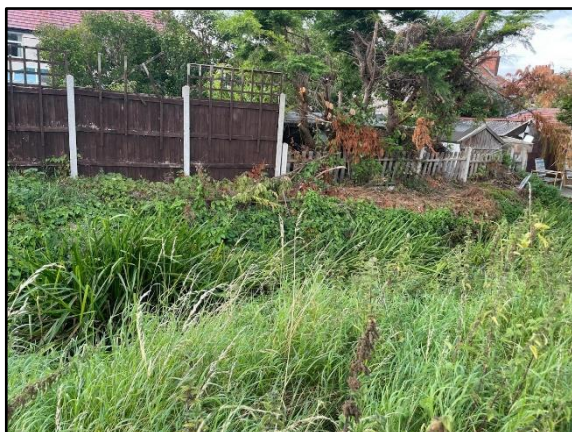
Photos 6.1 & 6.2: Photos taken of Prestatyn Gutter on 20th August 24, prior to it being dredged.

- 6.2.2 During the PEA on 20th August 2024, the ditch (viewed from within the site) was observed to be well-vegetated, with vegetation (mainly grasses) present along the banks and within the water. The northern bank of the ditch abutted residential gardens, featuring trees and shrubs (Photo 6.1 & 6.2). However, during a subsequent survey of the watercourse to undertake the otter and water vole survey on 23rd October 2024, the ditch had recently been dredged, resulting in the removal of all aquatic vegetation and the cutting back of the vegetation along the banks (Photos 6.3 & 6.4).

- 6.2.3 The ditch was approximately 2m in width and 0.5 to 1m in depth with earth banks.

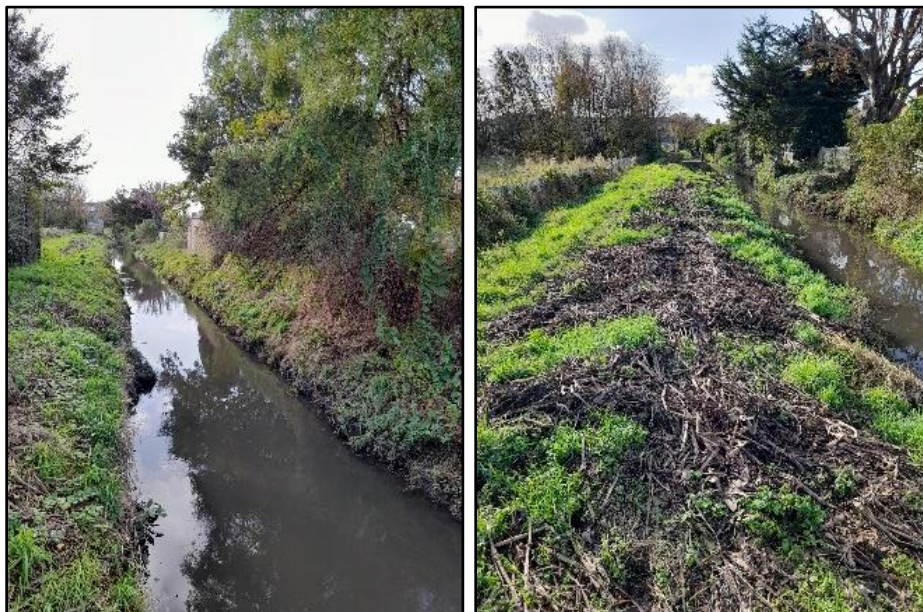
Photos 6.3 & 6.4: Photos taken of Prestatyn Gutter on 23rd October, after being recently dredged.

3.9.2 During the survey on 23rd October, it was found that the length of drainage ditch adjacent to the site had very recently been dredged and the vegetation on the banks had been cut short. Although this will have removed many of the signs of otter and water vole that would have been surveyed for, it did however make it easier to see water vole burrows (if present) and potential otter holts.

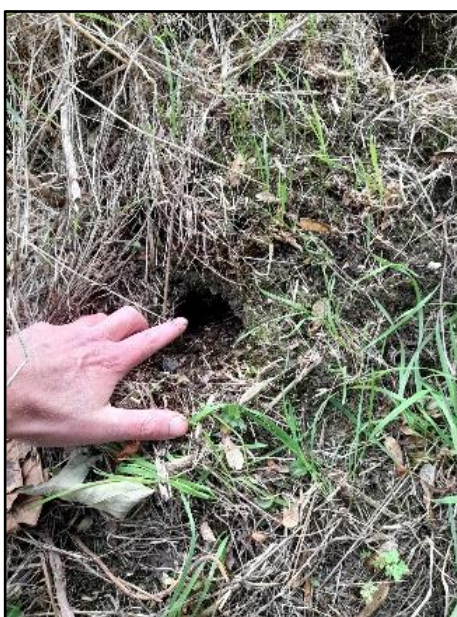
Photo 6.5: Old water vole burrow

- 6.2.4 A number of old burrows, which were consistent with water vole, were identified along the banks. No recent signs were seen, however these would have likely been removed during the dredging process.
- 6.2.5 No evidence of otter was seen including no areas that would be suitable for a holt.
- 6.2.6 Both rat burrows and fresh signs of mink were identified.

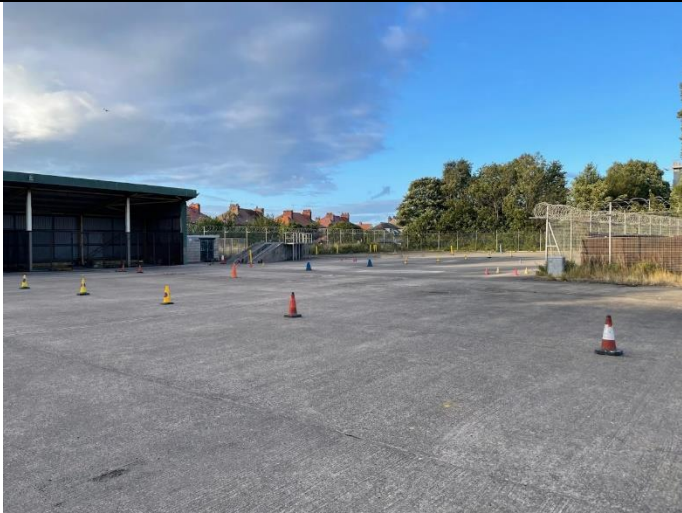
Description	Photo
Hardstanding	
In addition to the buildings (discussed previously in section 4.5), the site comprised a large area of concrete hardstanding, which was in good condition and in use as a driving training facility.

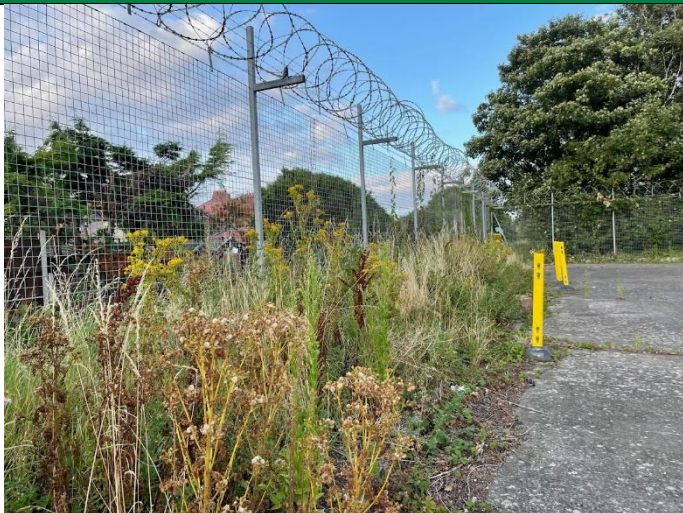
Tall Ruderal	
Along the northern site boundary was a strip of tall ruderal vegetation at the foot of the wire boundary fencing. Species included bramble (<i>Rubus fruticosus</i>), common nettle (<i>Urtica dioica</i>), common ragwort (<i>Jacobaea vulgaris</i>), ivy (<i>Hedera helix</i>), red valerian (<i>Centranthus ruber</i>), broad-leaved dock (<i>Rumex obtusifolius</i>) and grasses.

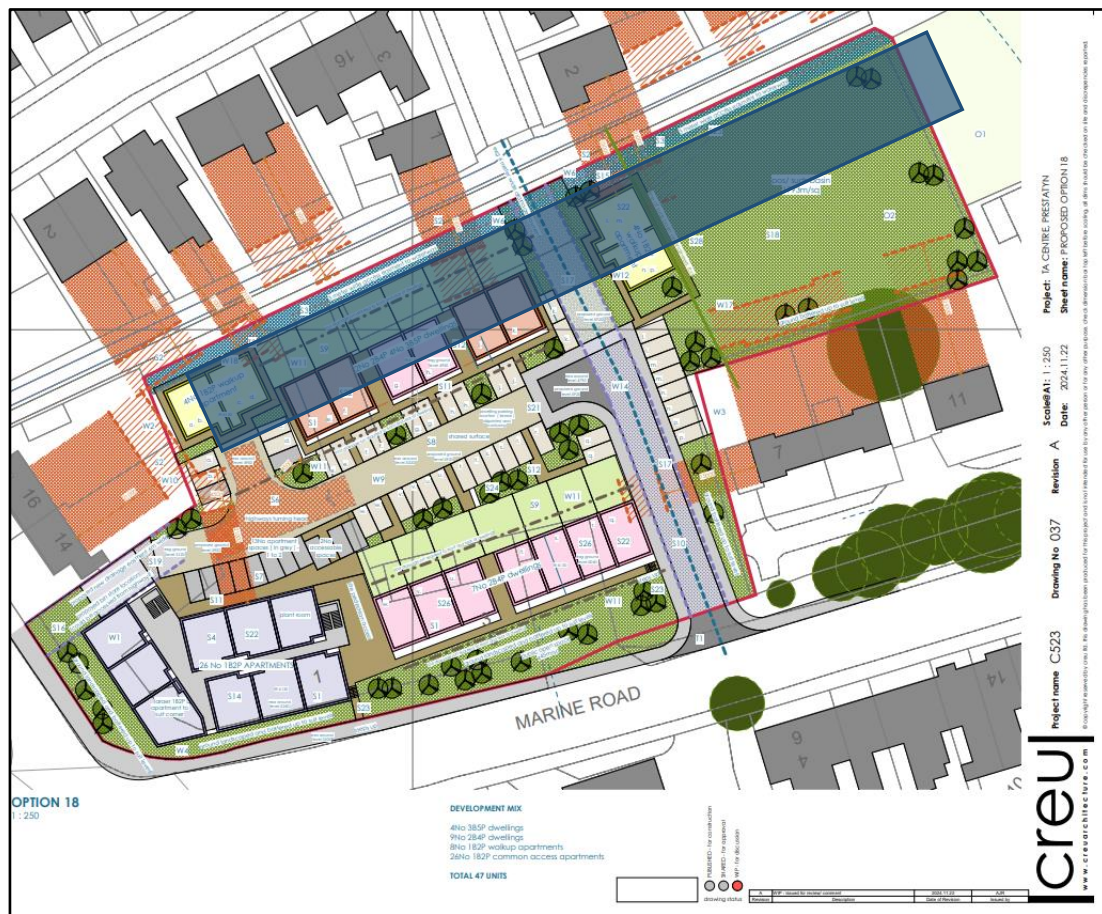
- There should be no illumination of the new bat and bird boxes once the works are complete.
- A darker 'buffer zone', where there should be no illumination, will be created along the northern site boundary.
- Any external or security lighting should be limited to provide some dark periods during the night. Ideally the lighting should be motion activated, and not stay on longer than one minute, in order to provide maximum darkness when not needed as well as providing safe lighting conditions for residents when required.
- During the period of works, works should be avoided within 1 hour of dawn and dusk to avoid disturbance to nocturnal animals (especially during the time when bats are active April – October). If works outside this time are needed, all lighting should be directional and be directed away from the northern site boundary.
