Updated Preliminary Ecological Appraisal, Preliminary Roost Assessment and Nesting Bird Assessment of Maes Emlyn, Rhyl

Report Reference: EE.5433.25.DA

Site	Maes Emlyn, Rhyl, LL18 3SF	OS Grid Reference	SJ0148 8161
Surveyors	Daisy Askari (accredited agent on NRW bat licence S092545/1) and Lowri Parry	Survey Date	12/11/2025
Type of Survey	Preliminary Ecological Appraisal, Preliminary Roost Assessment, Daytime Bat Walkover and Nesting Bird Survey.		
Summary of Proposed Work	Demolition of the existing buildings and construction of a residential development.		
Designated Sites Affected	There will be no designated sites affected by the works proposed.		
Habitats Affected	Trees, buildings, hardstanding and amenity grassland.		
Species Affected	There is potential for impacts on bats, nesting birds, reptiles, amphibians, hedgehogs and other fauna from the works. RAMS will be given in a forthcoming Mitigation and Conservation Plan to minimise the impact of works on protected species.		
Survey Results	<ul style="list-style-type: none"> Phase 1 habitats within the survey area included amenity grassland, hedgerow, buildings, hardstanding, mixed parkland and scattered trees. Invasive non-native

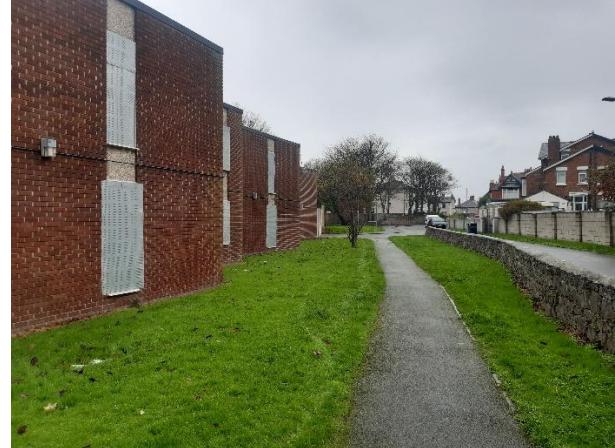
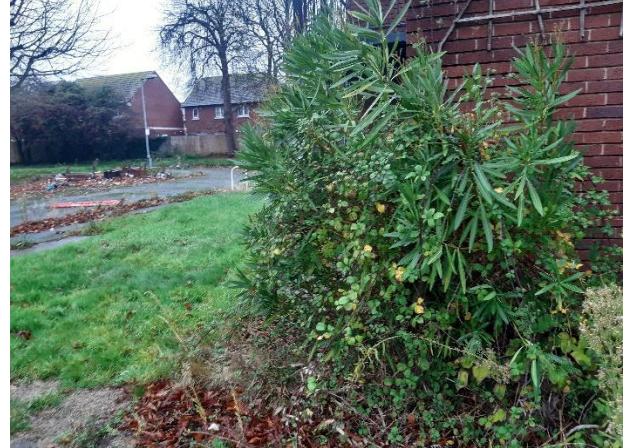
Habitat Description	Photo
<p>The majority of the site surrounding the buildings was amenity grassland. Dominant species were perennial rye grass, Yorkshire fog, creeping buttercup, dandelion and common nettle. Other species present included ragwort, carrot, ribwort plantain, broad-leaved plantain, bindweed, milk thistle, hogweed, petty spurge, self heal, cat's ear, black nightshade, white stonecrop and sorrel.</p> <p>The sward height was higher than on the previous survey.</p> <p>There was ornamental planting around some of the buildings with species including buddleia, stinking iris, elephant ears, oleander and aquilegia.</p>	<p><i>Amenity Grassland</i></p>

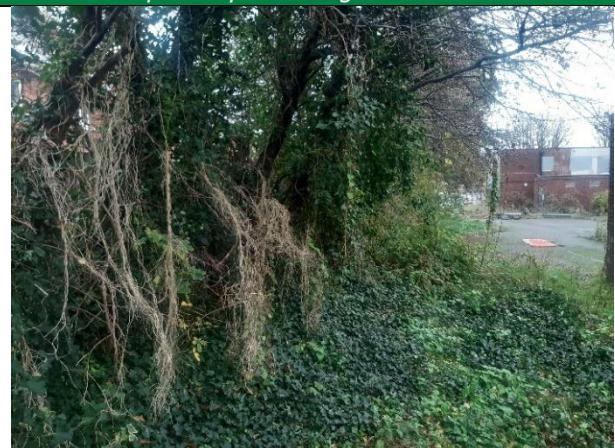
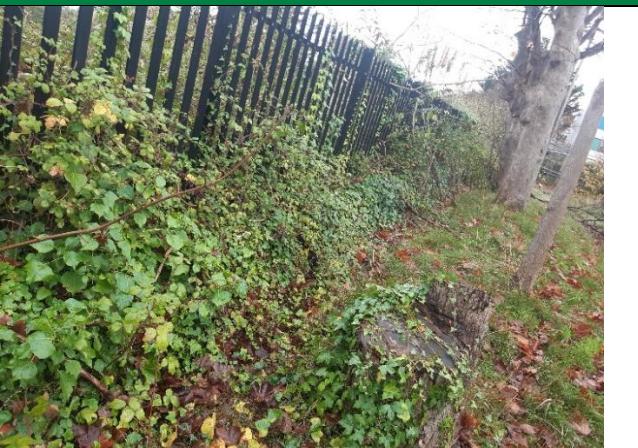
<p>There was a strip of native-species hedgerow with trees along the western border. This was largely hawthorn with several alder trees. The ground flora included ivy, bramble, common nettle, white clover, harebell, honesty, chicory, shepherds purse and rosebay willow herb.</p> <p>There was also a low, loose 'hedge' of bramble growing through the fence with white clover, harebell, honesty, chicory and shepherds purse.</p>	<p><i>Species-poor Hedgerow with Trees</i></p>

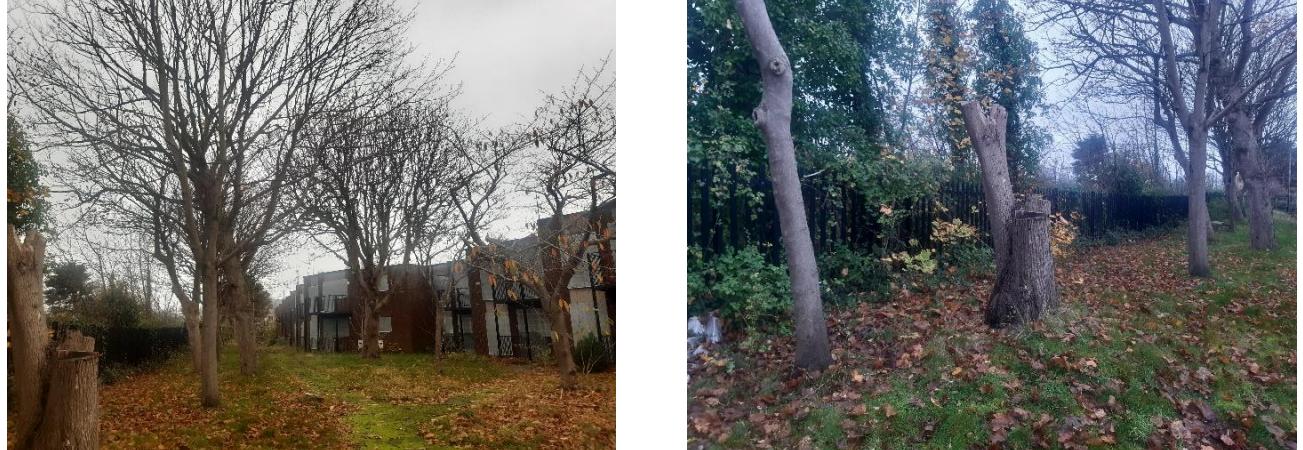
<p>Mixed parkland habitat was present along the southern border of the site, adjacent to the railway line. Tree species included sycamore, cherry, ash and horse-chestnut.</p> <p>There were scattered native and non-native broadleaf trees around the central carpark, the northeast border and the northwest border. These included sycamore, hawthorn, cherry and horse chestnut species.</p>	<p><i>Mixed parkland & scattered trees</i></p>

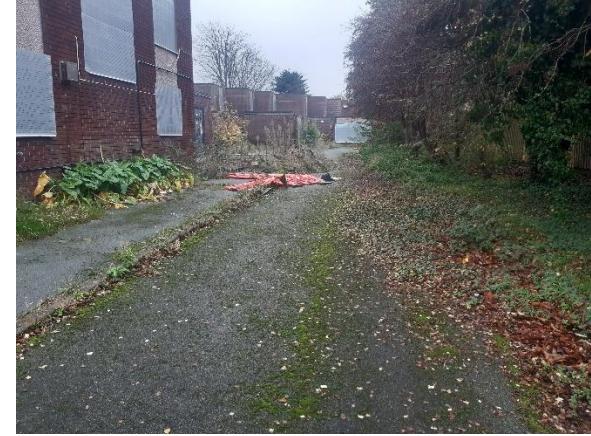
<p>The road leading into the site to the central carpark and to the western border, constituted the main areas of hardstanding. In addition, there was a pathway around the perimeter of the site and individual pathways leading to some of the flats. This habitat was partially colonised by mosses and white stonecrop.</p>	<p><i>Hardstanding</i></p>

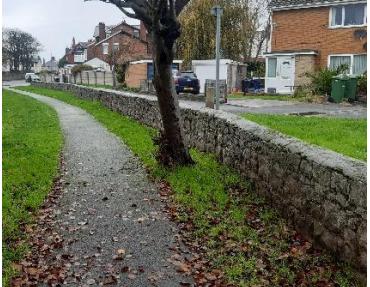
7	There was a stone wall at the northern and eastern site boundaries. It appeared to be well-sealed with no visible crevices for birds and other fauna to use.

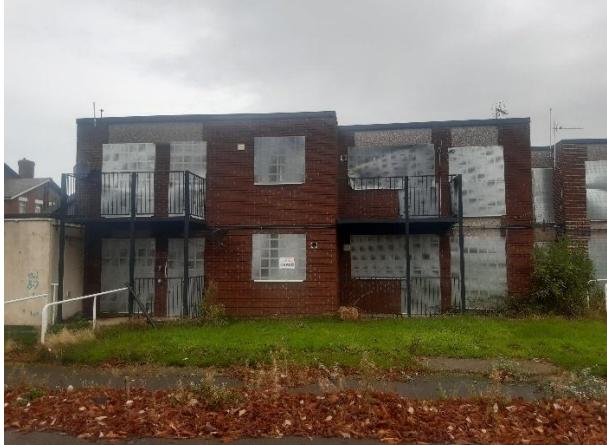
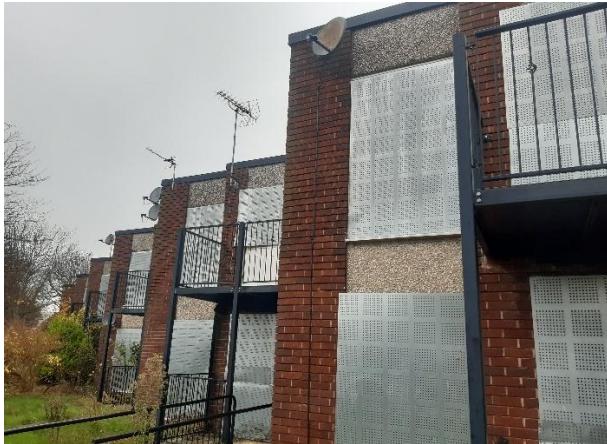
External Description	External Photo	Internal Description	Internal Photo
<p>The flats were generally uniform in construction with brick walls and flat roofs. All of the roofs appeared to be of the same construction with composite cladding/flashing along the edges.</p> <p>In place of the windows and doors was a pre-cast concrete section or pebbledash. Some of the upper flats had a steel balcony. On several flats some of the walls were rendered over completely. All the windows and doors were covered over with metal security sheeting.</p>

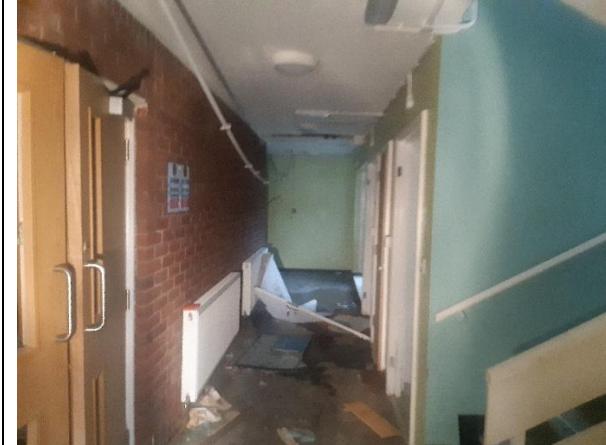
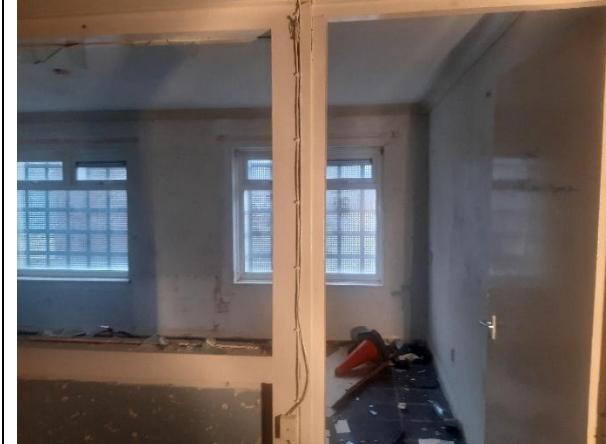
<p>Flat 50, within block 2 of the flats, was inspected internally. The walls were plastered and well-sealed with double glazed windows. There was no attic or roof space within the buildings due to the flat roofs.</p>

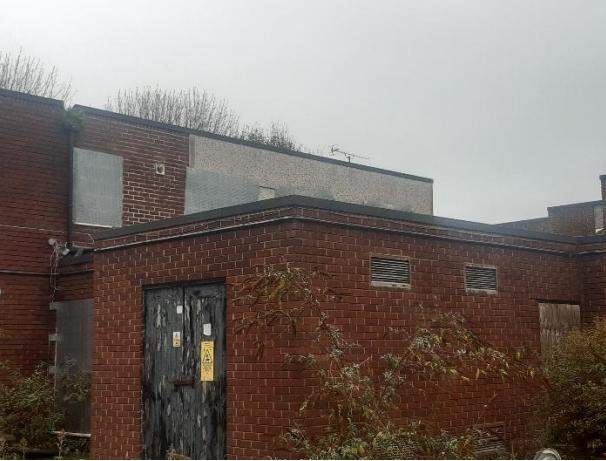
Maes Emlyn- Outbuildings			
External Description	External Photo	Internal Description	Internal Photo
<p>There were brick-built sub stations and a shed at the rear of block 2. The sub-stations were approx. 2.5m high by 4m wide and 4m long, whilst the shed was the same height and length but only approximately 1.5m wide.</p>

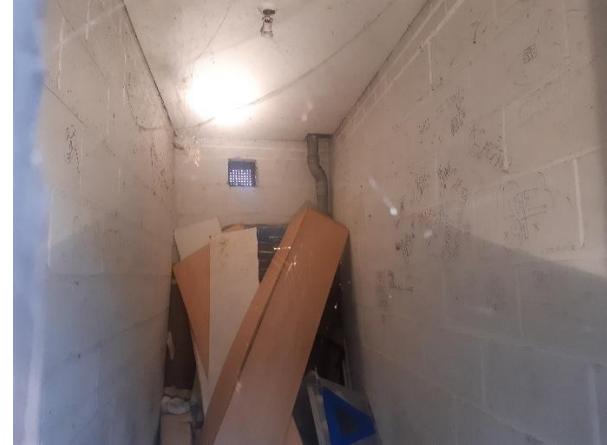
<p>The plant rooms and sheds appeared to have block walls internally with false ceilings, and were used for storage. There was no attic or roof space within the outbuildings.</p>

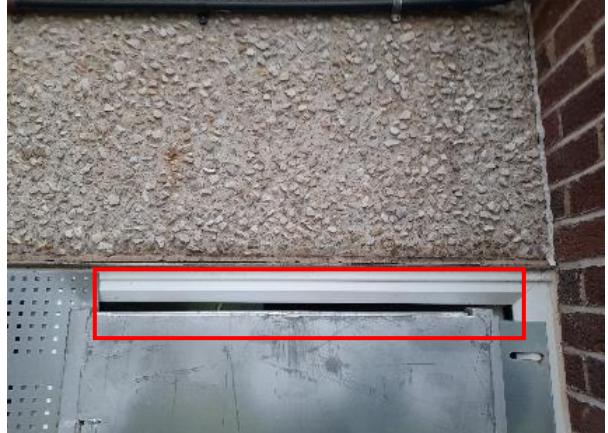
Open door behind a small gap in the security metal sheeting at block 2.

5.7.2 There was potential access for bats into block 2 of the flats via boiler vents and gaps behind metal sheeting. Internally the building was well-sealed with no available roosting features for bats. The interior of block 2 was inspected and conditions were light and draughty. It is deemed unlikely that bats would use the internal spaces of the building for roosting. There was no access identified for bats into block 1 or the outbuildings, and these were well sealed externally.

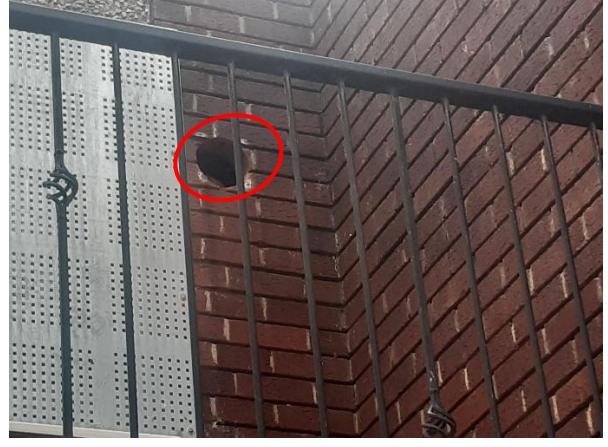
Vent holes in brickwork at the southern elevation of block 2, which could provide access for bats and birds into the building.
