**Ty Gwynn Jones, Abergele**

## **Bat Survey Technical Report**

**Prepared For: Enfys Developments**

Document Reference: 11137.002

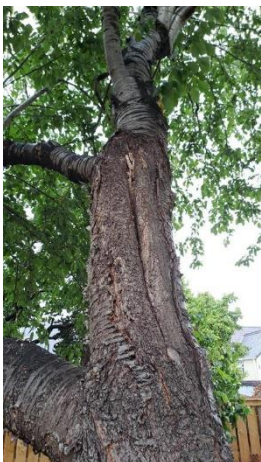
- 4.8 Following the PRF inspection survey, tree T2 (located at grid ref: SH 94952 77467) was assessed to have PRF-I bat roost habitat suitability.
- 4.9 No residual evidence was identified on or in T2 during the PRF inspection survey. The detailed findings and a photographic record are presented in **Error! Reference source not found.**

| T2 | <p>PRF 1 - The tree is measured to have a DBH of ~90cm. PRF is a tear in the trunk, located approximately ~2.2m from ground level on southern aspect (south facing). PRF measures approximately 10cm wide and 35cm high.</p> <p>Categorisation: PRF-I</p> | | Visit 1 -<br>22/07/2025 | No bat evidence found. |

- 6.5 Should tree T2 require removal, this will impact bat roost resource availability within the site. Where bats are transitional in their use of roost habitat roosts may be destroyed or roost functionality impacted by severance of commuting routes and indirect disturbance from external lighting.

- 6.8 If works on trees with bat roost habitat suitability are required (including removal or pruning) a Precautionary Working Measures Method Statement (PWMMS) should be produced and implemented. The PWMMS should include details of precautionary soft felling measures to be implemented whilst removing or pruning trees with bat roost habitat suitability. Precautionary soft felling measures should include:

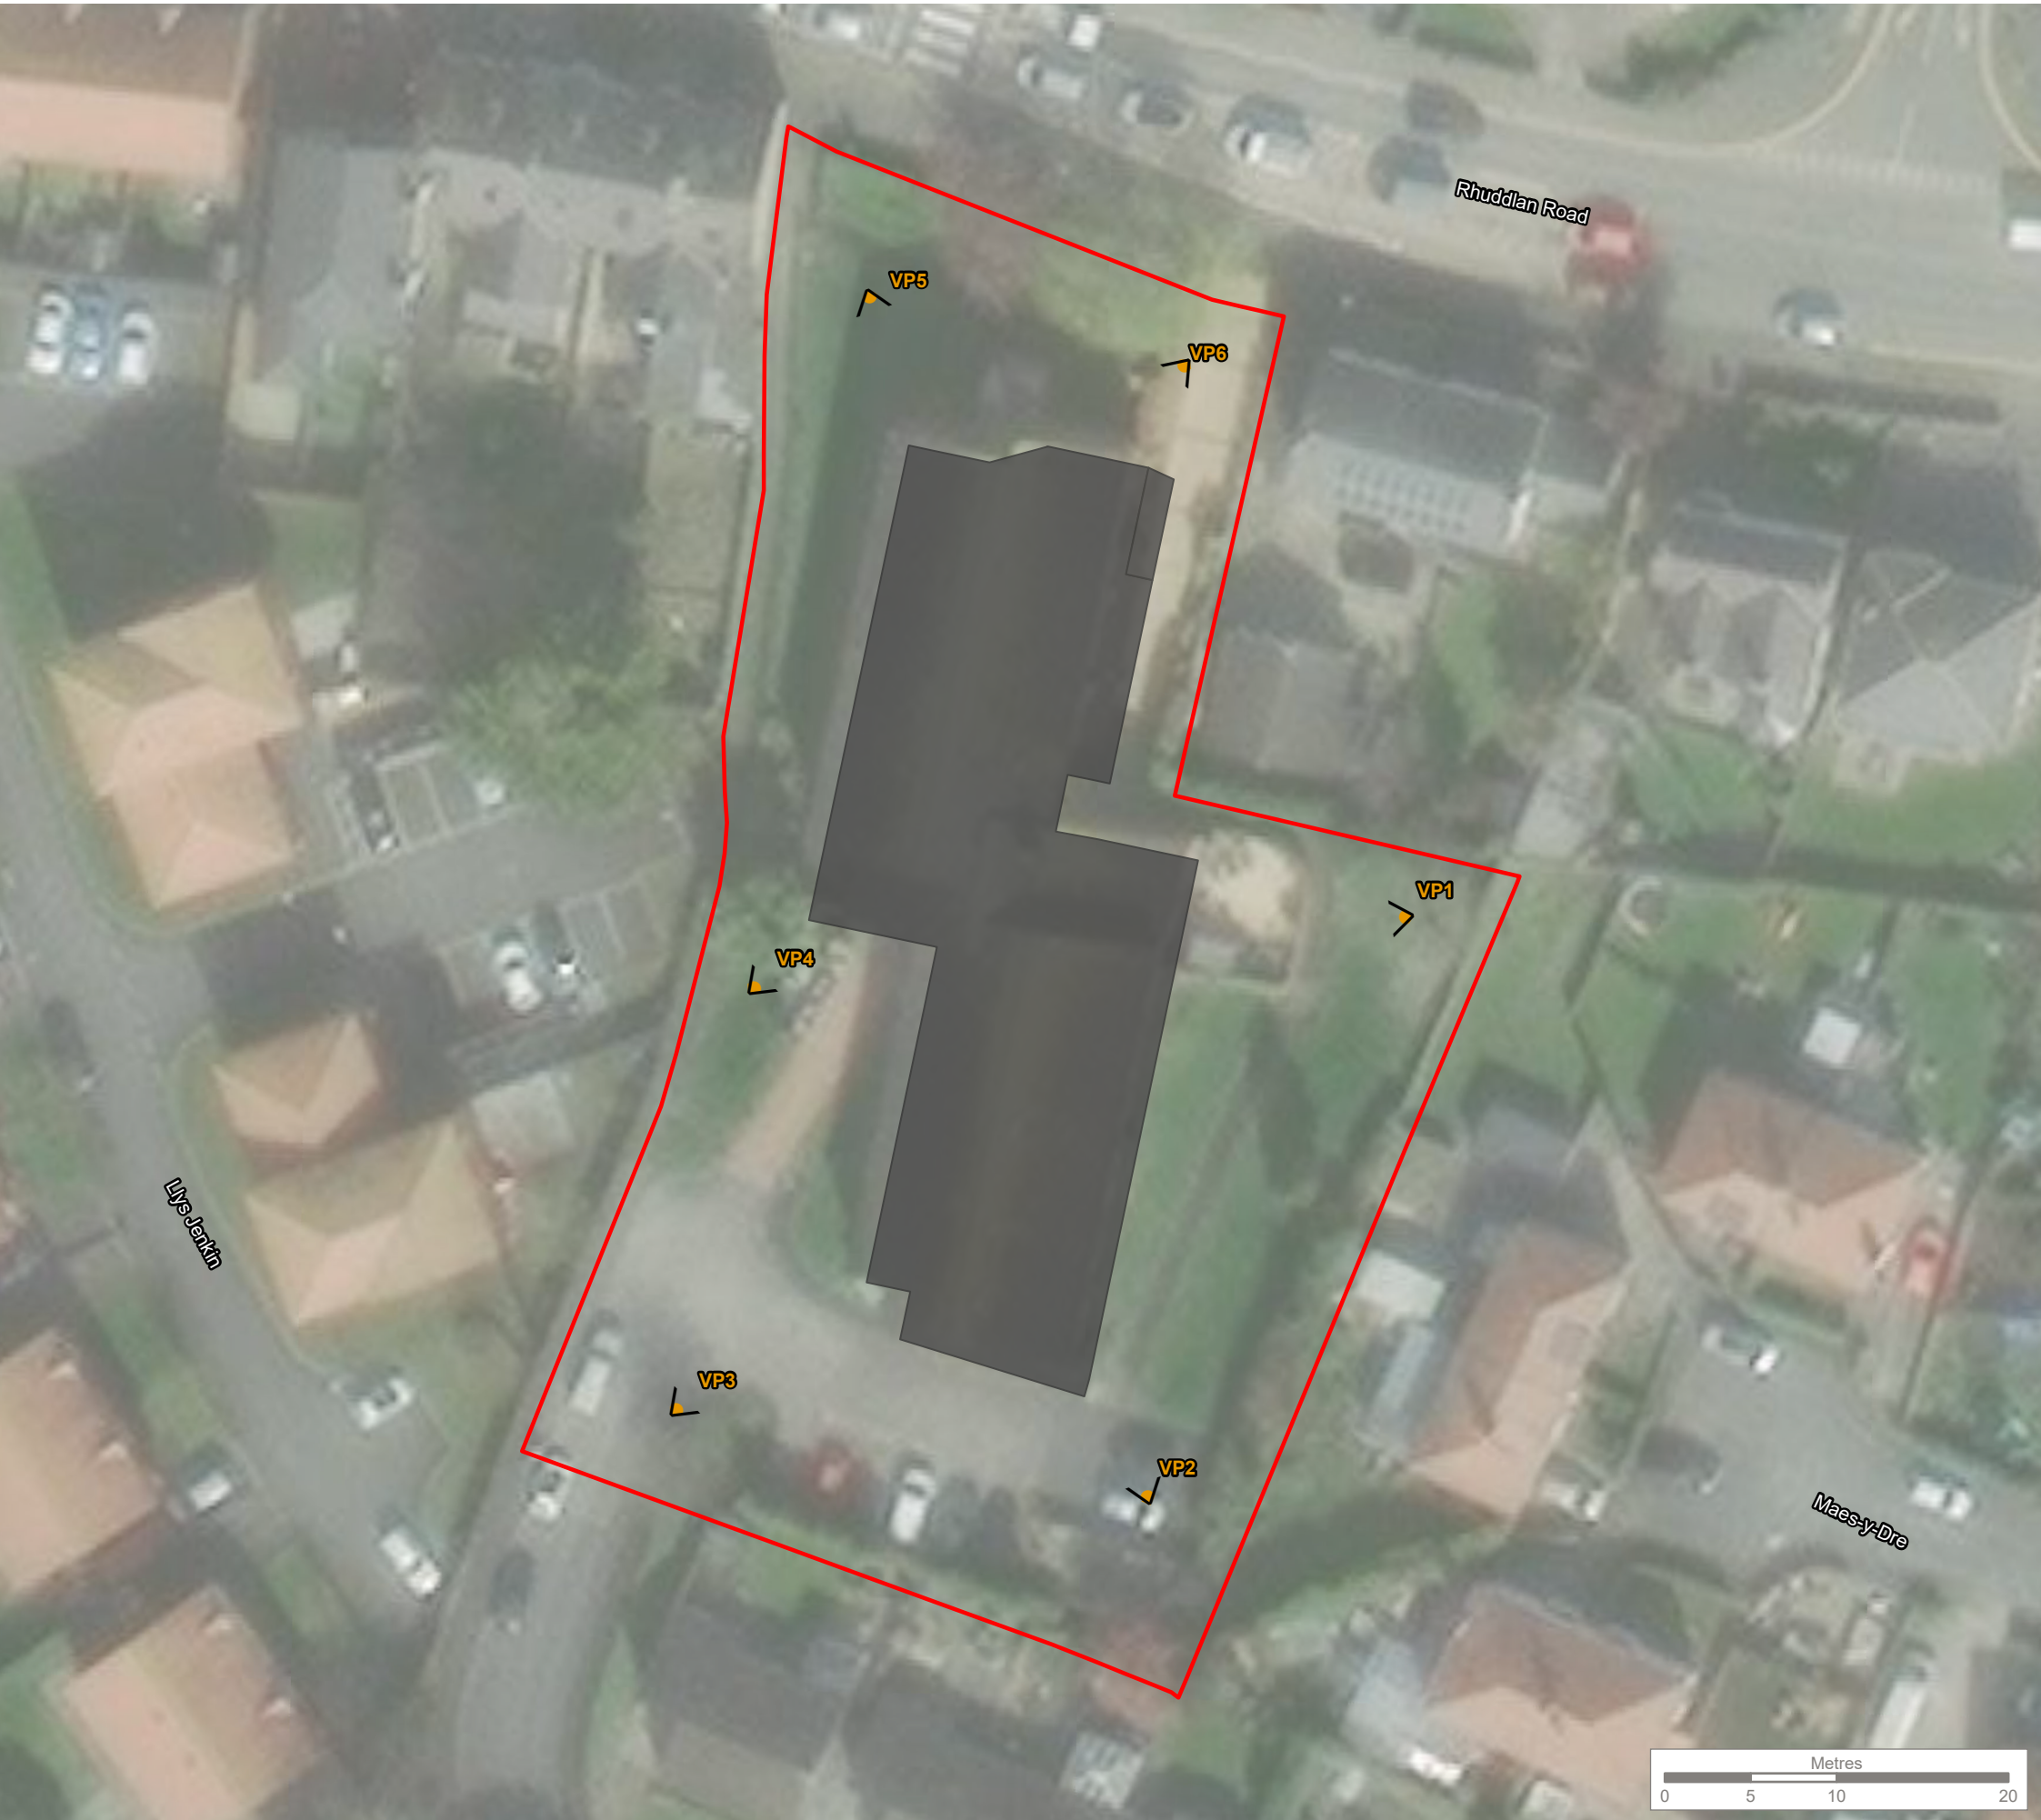
### Drawing 1: G11137.007 Surveyor Vantage Points, NVA Locations and Survey Results

- 4.5 Nocturnal presence/likely absence emergence surveys supported the findings of the PRA. Surveyor vantage points and NVA locations used to gain coverage of B1 aspects/elevations and PRFs in addition to bat activity observations are shown on TEP Drawing G11137.007.
- 4.6 No evidence of bat roosts or roost activity was recorded during the surveys.

No bat emergence recorded during visit.

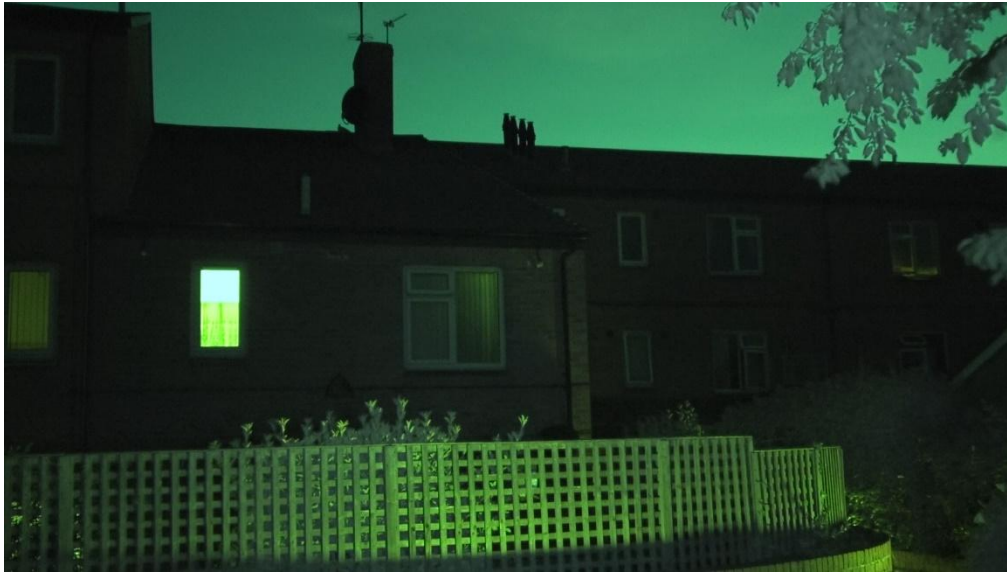
Figure 2: VP1 17.06.25

- 6.56 A screenshot from the NVA footage of the darkest point during each survey is taken during data analysis post-survey, to illustrate the field of view and extent of illumination during the surveys.
- 6.57 Survey footage is reviewed in real-time post-survey and cross checked in combination with observations recorded by surveyors on field forms. NVA footage is automatically broken down into 5-15 minute files. Where bat roosting is recorded/suspected, footage is reviewed at 1x or slower playback.
- 6.58 Results between surveyor observations, bat detector recordings and NVA footage is analysed and cross-referenced to more accurately establish survey results and confirm presence/likely absence of roosting bats.
